Housing Buildings' Characterization at Corvo Village (Azores) Historical Center: Towards a Sustainable Rehabilitation Process

Abstract: Corvo is the smallest island of the Portuguese archipelago of the Azores and an unexplored territory, with one single village. Scarce studies have been conducted regarding its built heritage, and deep knowledge of the constructions is necessary for conservation actions to be carried out. This article presents the architectonic and constructive characterization of housing building features that compose Corvo village's historical center, focusing on its characteristics, dissonances, and conservation state. A case study regarding one housing building is presented. This research intends to contribute to a deeper knowledge of these buildings' identity, constituting the first step towards future rehabilitation processes that can improve the inhabitants' quality of life and simultaneously value the territory's singularity.

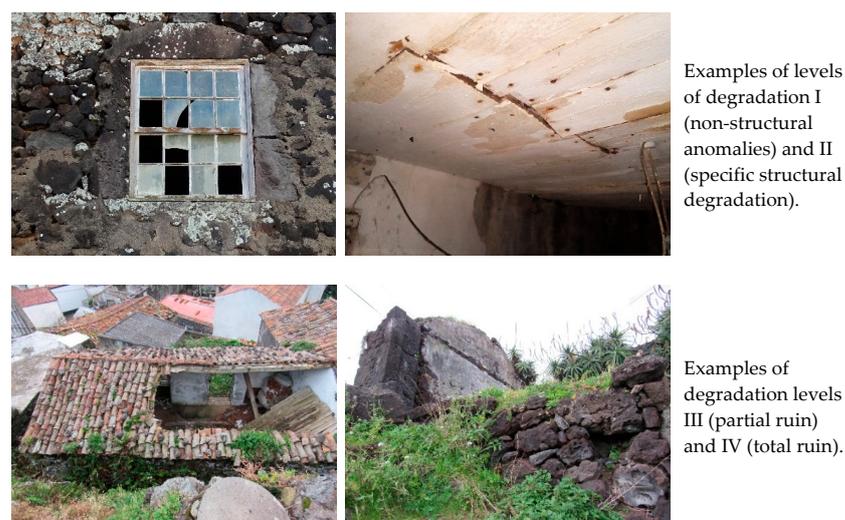
- a. Degradation level IV—The existing building is mainly composed of remaining parts of the previous wall structures, which have already collapsed (ruin state);
- b. Degradation level III—The building is only composed of the exterior walls (the roof, intermediate floor structures or both, have already collapsed). The building thus maintains its external structure intact, yet without resistance capacity;
- c. Degradation level II—The building has walls, a roof, and an intermediate floor. However, the structure of the middle floor is unstable, has evidence of structural damage to the roof, or both. The buildings have pathologies such as lack of material, namely with voids in their stone walls, among others; and
- d. Degradation level I—The building does not have structural damage, despite having other anomalies capable of being corrected.

Figure 12. Examples of building degradation situations.

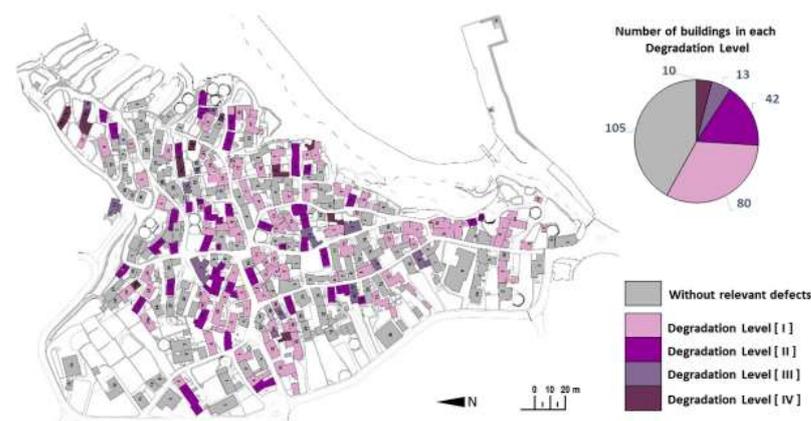
Degradation level I, related to non-structural anomalies, was the object of a detailed complementary study to identify the different types of anomalies [22], where defects in roofs, wall coverings, and windows were highlighted, with problems of humidity, cracking, aging of materials, and maladjustment in view of current functional requirements. Figure 12 illustrates the different levels of degradation and Figure 13 shows the location of buildings in the urban grid according to this classification.

Figure 13. Number and location of buildings, according to the level of degradation.

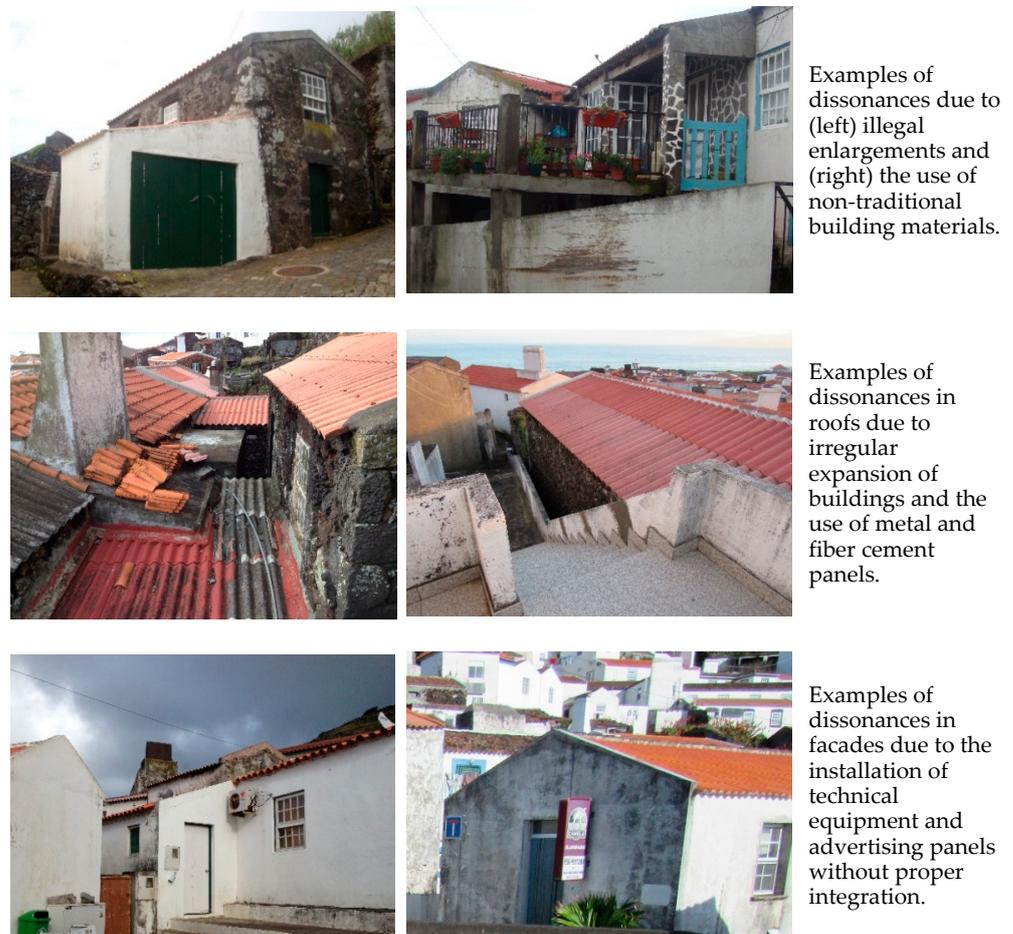
As mentioned in the Regulatory Decree [36], many interventions carried out over the years were not framed by a global strategy, nor supported by a detailed project, often leading to dissonances that need to be evaluated and, when necessary and possible, corrected. From the observation of the NAVC buildings, 26 types of alterations performed on buildings were considered to have led to significant dissonances. The buildings were grouped into levels of dissonance according to the following criteria: Level I—Does not present dissonances; Level I—Low: one to three dissonances; Level II—Medium: four to six dissonances; Level III—High: contains seven to nine dissonances; Level IV—Very high: contains more than 10 dissonances. Figure 14 illustrates some of the dissonances observed and Figure 15 shows the location of buildings in the urban grid according to this classification.

Figure 14. Examples of observed dissonances in NAVC buildings.

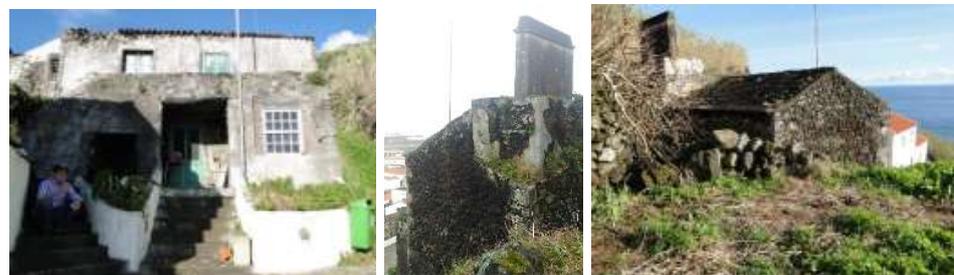
Figure 16. General views of the building surveyed.

On the lower floor there are two spaces separated by a masonry wall made of concrete blocks, which resulted from unfinished work for the eventual creation of a bathroom. The larger space has a mixed function between “cellar” and kitchen, with an exterior wood-fired oven. The pavement consists of a mortar screed executed directly on the ground.

The interior connection between the two floors is made through a reinforced concrete stairway that is totally different from the original construction system. The upper floor has a wooden structure and is in a significantly bad state of conservation. The degradation of the roof is also severe.

The upper floor consists of a single habitable compartment, used as a bedroom. The habitability conditions of the building are very bad, not only due to its degradation, but also due to the small space and the lack of basic equipment and functionalities.

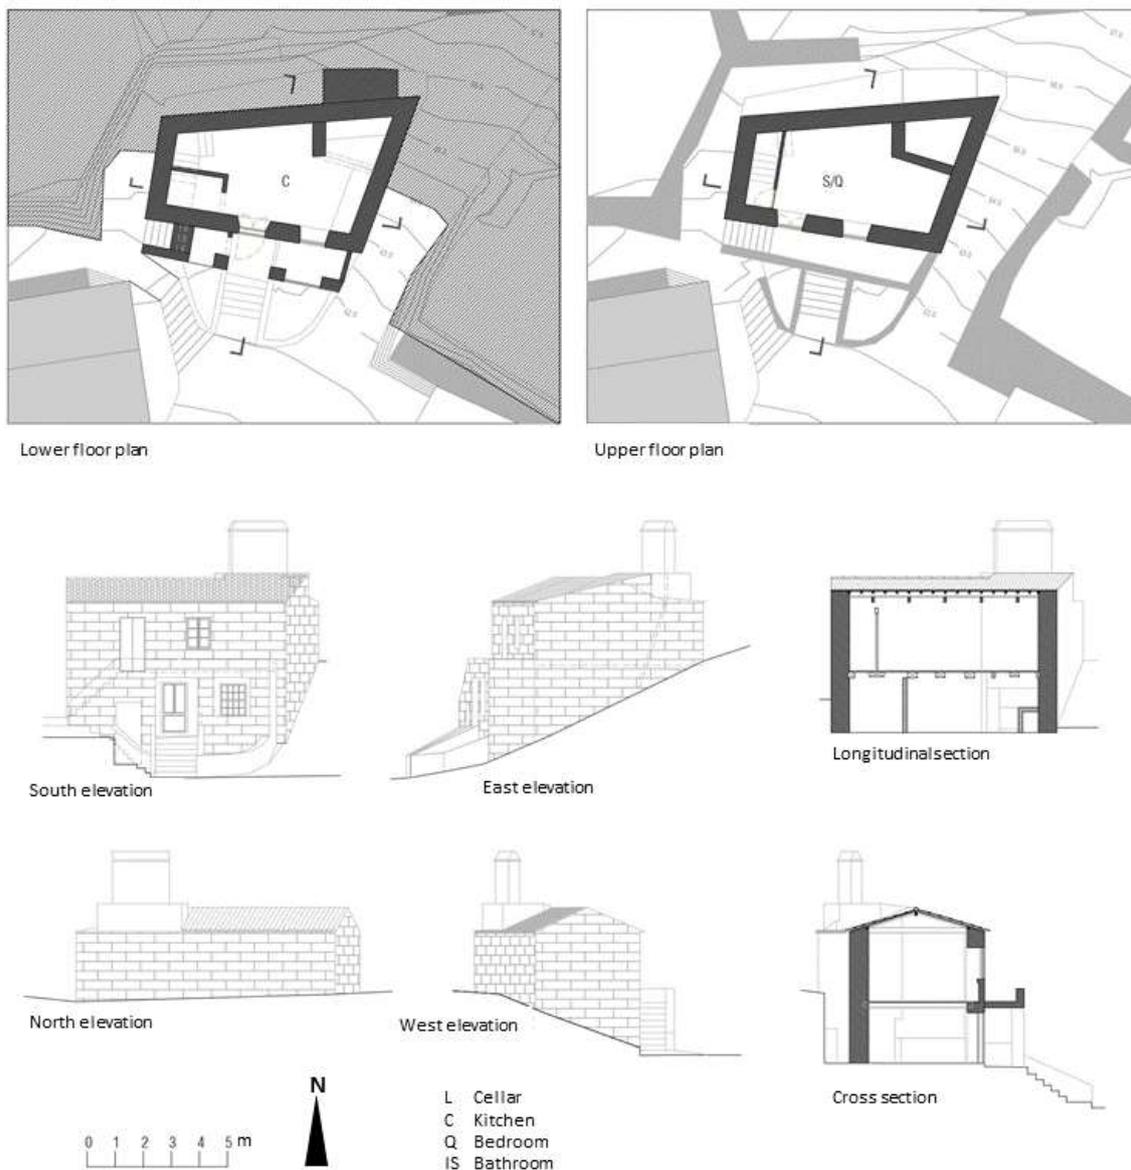
The difficulties resulting from partial and very poor interventions carried out over time also contribute to the lack of suitable living conditions. Thus, the challenge of the intervention was to make the most of the space and provide the house with suitable living conditions, respecting the guidelines of the specific regulations created in 2015 by the Regional Government of the Azores. Figure 18 presents architectural plans for the intervention proposal.

Figure 17. Example of the architectural survey of one building.

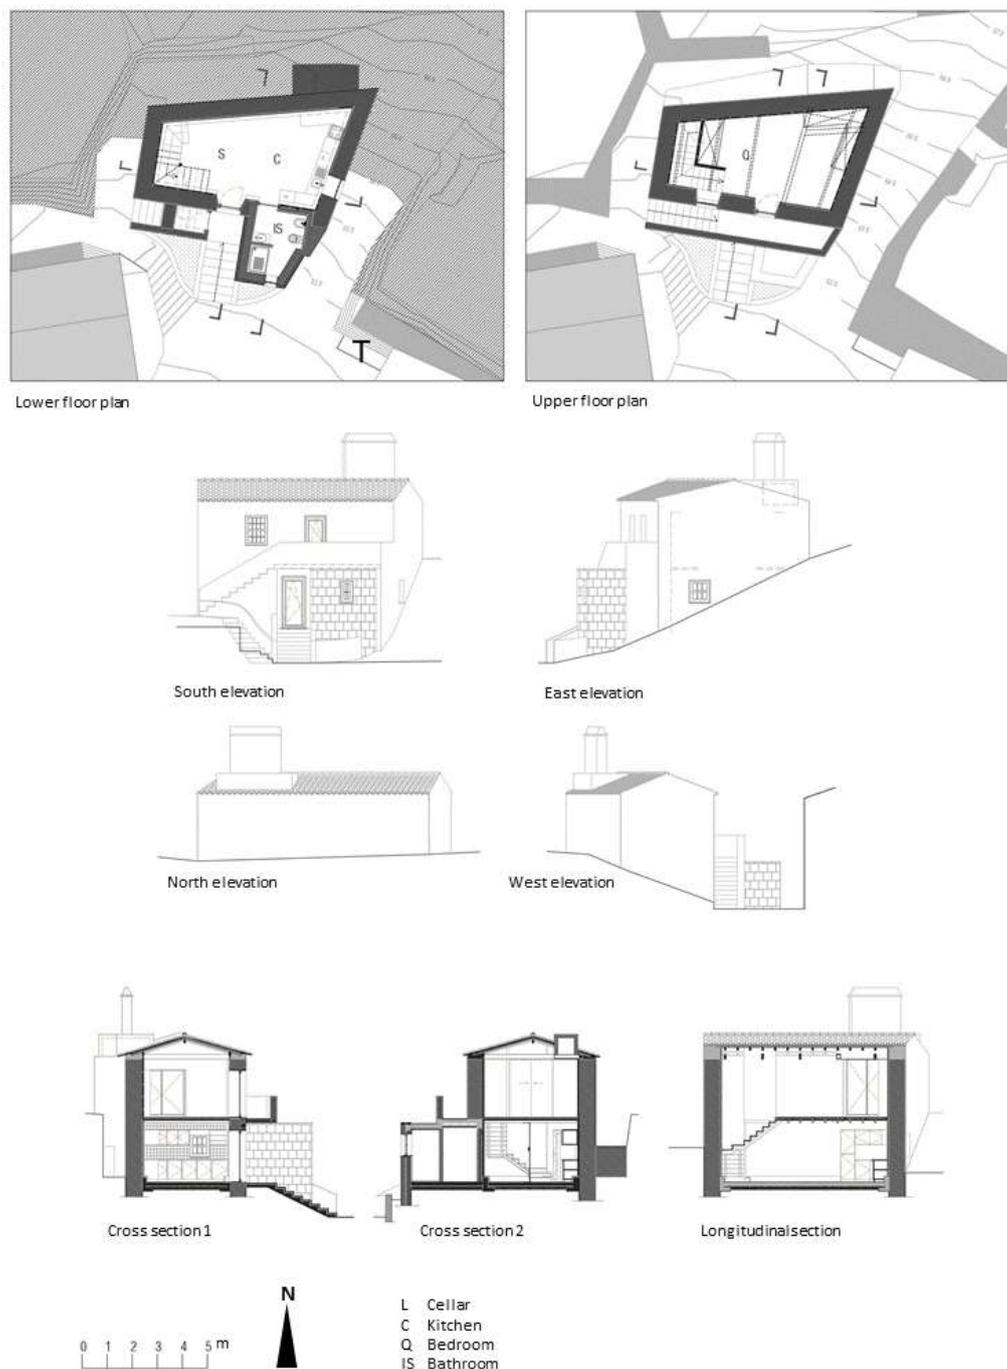
Figure 18. Architectural plans for the intervention proposal.

The dismantling of the stone stairs and their subsequent reuse is foreseen, as well as the construction of a small space to install a bathroom, which would be articulated with the original building.

The lower floor level would be lowered to increase the space's height. This floor would be reorganized to maintain and improve the kitchen functions, now including the "dining room" function. Here, the dissonant elements would be demolished. The interior access to the upper floor would be replaced by a wooden staircase, which would replace the concrete staircase. On the upper floor the spatial organization would be maintained, but with improved comfort and healthiness and with the exclusive function of a bedroom.

In view of the poor conservation state of the existing wooden floor of the upper floor, it was decided to reconstruct it with an identical technical solution.

The windows and doors would also be replaced by traditional wooden solutions, but with better performance than the existing ones. The same strategy would be adopted with the roof, taking the opportunity to make a slight correction of geometry and to create a technical element of lighting and ventilation.
