Cut slopes failures on the Triassic beds in Coimbra, Portugal

Abstract Several cut slope failures that occurred in the Triassic “Grés de Silves”, in the area of Areeiro in Coimbra, Portugal, are analysed. They developed along thin mudstone layers dipping at some 16° towards the face of the excavation. The failures mainly occurred after periods of intense rainfall, in some cases immediately after the excavation of the slope and in some cases have continued for the seven years since, even where the slope height was only a few metres. The conditions leading to the failures were investigated in the field and in the laboratory. It was concluded that the main factors inducing the slope failure are a conjugation of the geological structure and the reduction in the shear strength of the mudstones when the excavation results in dilation, such that fissures open allowing the ingress of water.

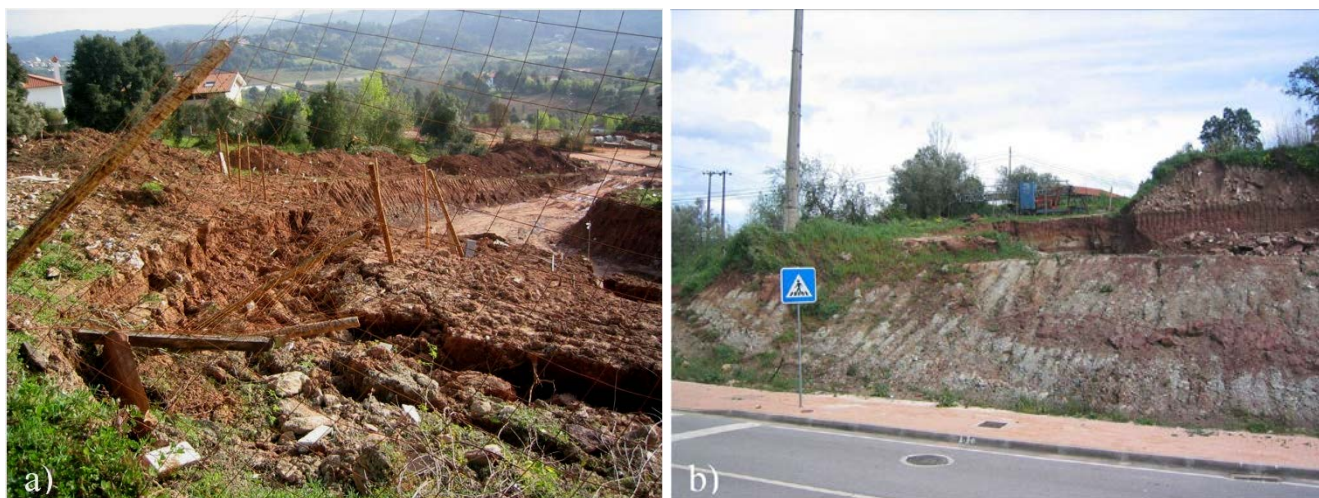
The first failure took place at the end of February 2004 after the excavations for the street to “Quinta do Areeiro” (Fig. 3). A landslide approximately 100 m long and some 12 m wide occurred following a 1.5 to 2.5 m high excavation. The slip occurred where the mudstone beds dip at some 16°, following a period of rainfall (Table 1). Chleborad (2000) defined the parameters P-3 and P-15 as the accumulated rainfall (in millimetres) in the three days or 15 days before the failure. In this study, the parameter P-30 is introduced corresponding to the accumulated rainfall in the thirty days before P-3. Remediation involved removing the failed ground and reducing the height and angle of the slope (Fig. 3b).

Fig. 3 Slide of the street to “Quinta do Areeiro” cut slope: **a** planar slide following excavation during construction, at the end of February 2004 and **b** geometry of the slope after removal of the failed ground, and final reshaping

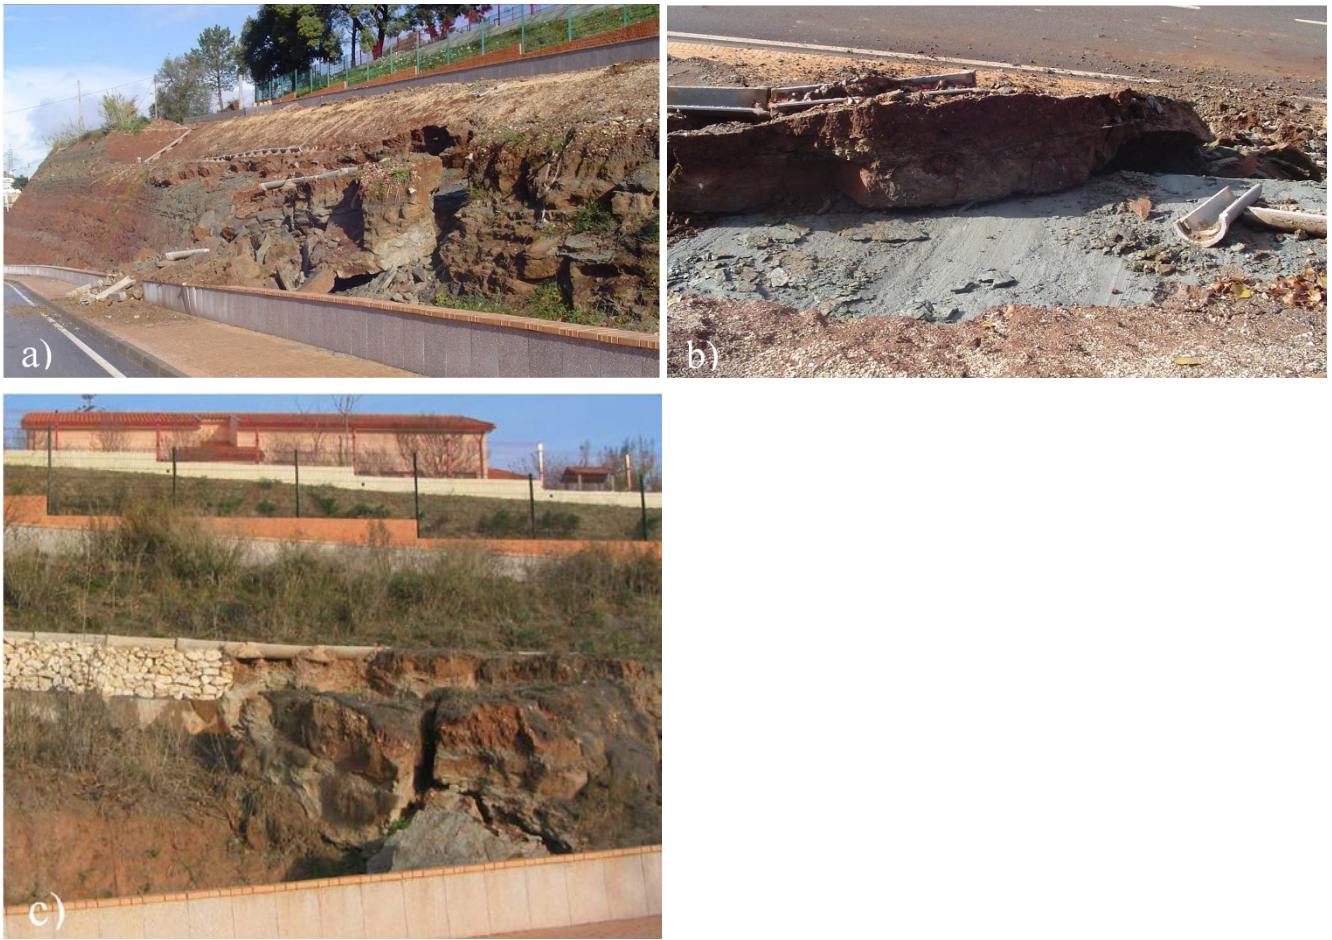
In 2005 a planar slope failure destroyed the superficial drainage system and the small retaining wall along the sidewalk. The remediation works carried out in early 2006 included the removal of the failed material, the reconstruction of the drainage and the construction of a free-draining rock buttress at the bottom of the slope. The affected area was covered with a biodegradable erosion control blanket to encourage re-vegetation. The small sidewalk wall at the slope’s toe was also re-built.

In December 2007, part of the undisturbed terrain to the right of the 2005 slide suffered a planar failure similar to the one that occurred in 2005, but of smaller dimensions (Fig. 4c and Table 1). At present, this failure still waits remediation.

The interval between the intense precipitation and the occurrence of the failure is the largest of the six landslides studied. This is attributed to the reduced infiltration into the ground as a result of both the school building and the asphalted playground, which increased the time taken for sufficient water to reach the slip surface and trigger the slide.

Fig. 4 Planar failures in the Areiro School slope. December 2005: **a** landslide occurred along the mudstone stratification, **b** slid block and slickenlines on the mudstone bedding plane. December 2007: **c** reactivation of the failure to the right of the 2005 slide

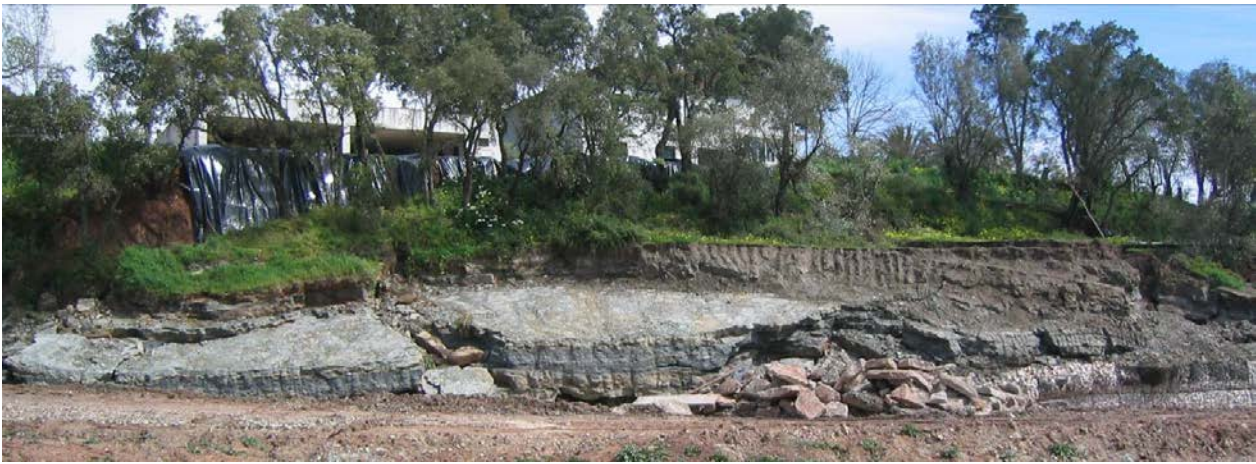
Enabling works for the construction in Quinta do Areiro, carried out in March 2006, involved the excavation of a sub-vertical slope, up to >5 m high (slope 3 of Fig. 2), which it was intended to stabilize with a gabion retaining wall. Shortly after excavation, a planar failure occurred along a mudstone layer intersecting the base of the slope, in the central and southern areas of the excavation (Fig. 5). The presence of a sub-vertical N48°W fault at the rear of the failed block and oblique to the excavation face, limited the slide volume but a 2 m wide, 3-5 m high tension crack developed. The slide destroyed most of the gabion wall that was under construction. The grey to greenish mudstone layer on which the landslide moved is orientated N26°W, 16°SW. The mudstone layer was 0.1 m to 0.3 m thick but composed of alternating light and dark coloured thin beds (only a few millimetres thick) related to the lacustrine sedimentation processes (Fig. 6). The stabilization of this slope was achieved by removing most of the failed mass above the sliding surface, re-shaping the slope and re-building the gabion retaining wall.

Fig. 5 Overview of the failed slope of “Quinta do Areiro” (March 2006). The black plastic liner in the background highlights the fault scarp oriented N48°W, subvertical, revealed by the slide

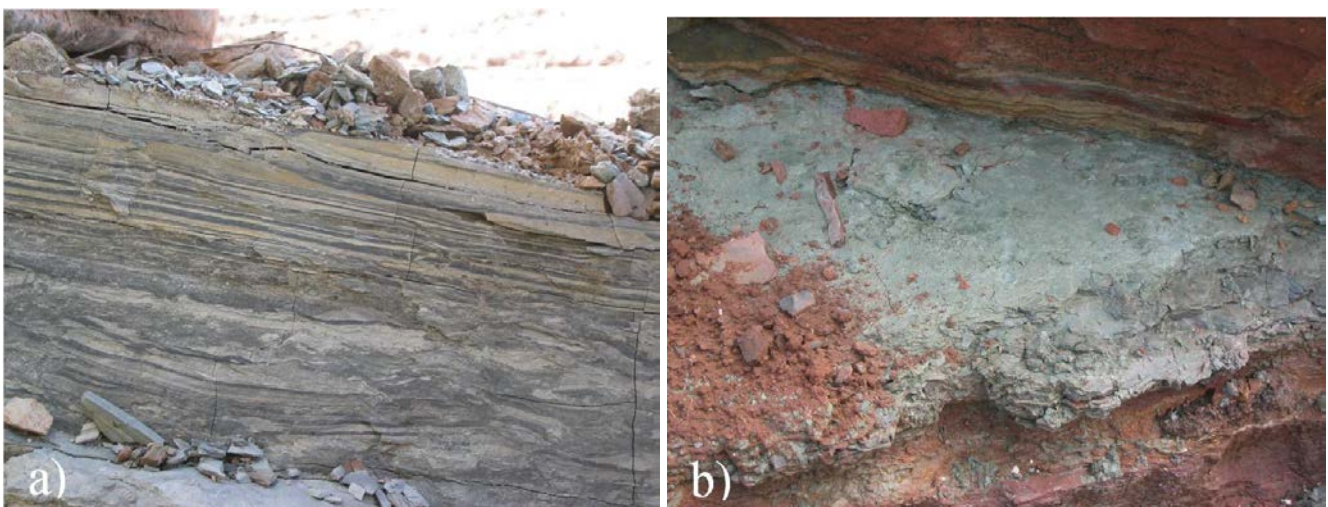
Fig. 6 Details of the mudstone layer responsible for the landslide of “Quinta do Areiro”: **a** alternating millimetric layers showing light and dark colours and **b** greenish slide mudstone surface, in the southern border of the landslide

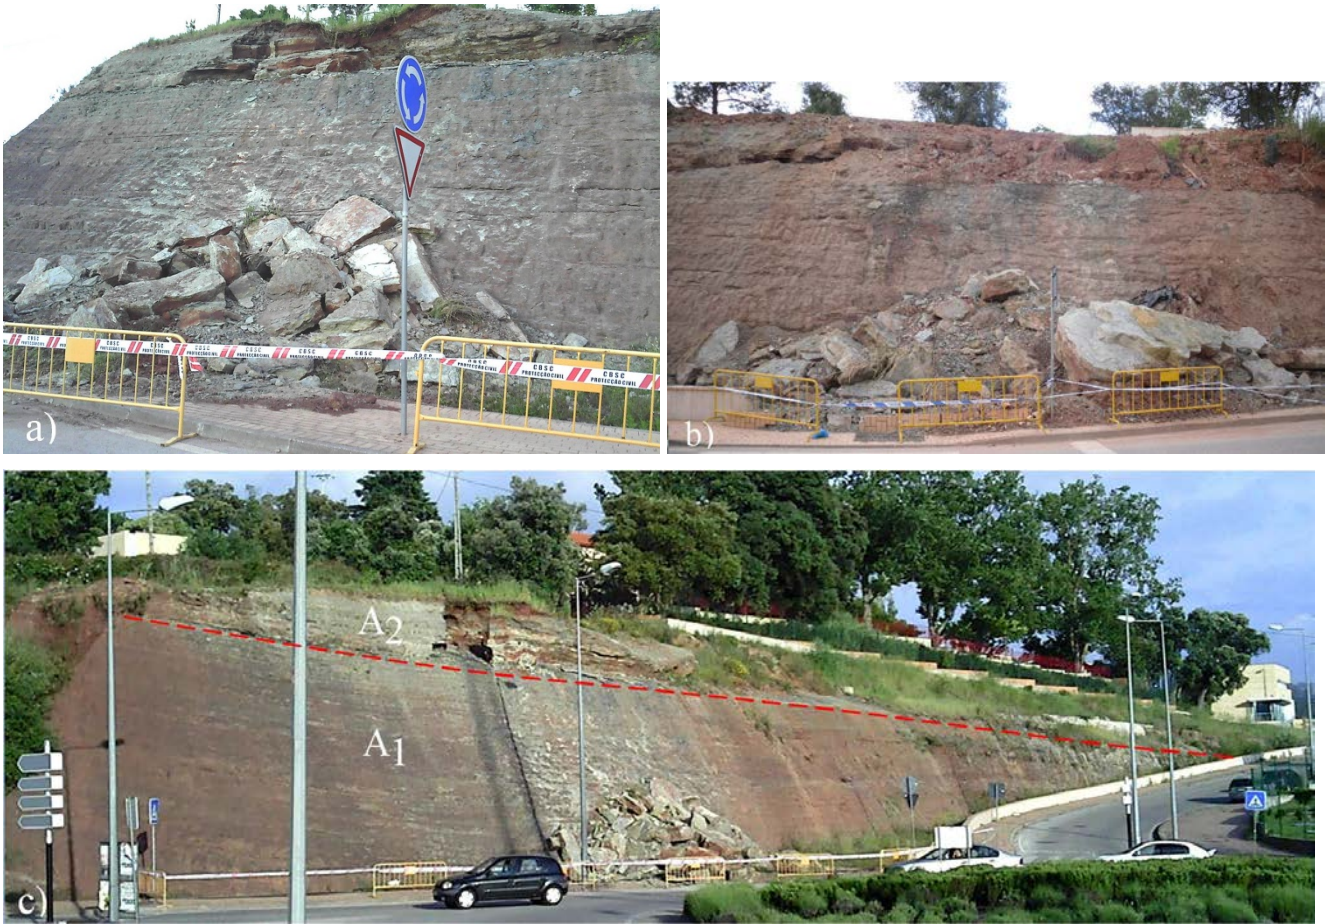
In the summer of 2009 it became apparent that the slope of the Areiro roundabout (slope 4 of Fig. 2), was developing a planar failure. The first failure occurred in mid April 2010 after a period of intense rainfall and the second a year later, in May 2011 (Fig. 7). In both cases, fallen blocks accumulated at the base of the cut slope, encroaching onto the sidewalk and part of the roundabout road pavement and posing a serious danger to pedestrians and drivers. The grey mudstone layer on which the movement occurred is clearly seen in the cut face at the transition between units A1 and A2 of the “Grés de Silves” (Palain 1973, Miranda et al. 2010). Although the fallen material was removed, the only stabilisation measure was to place a plastic liner over the surface of the slope. At present, therefore, the possibility of another slide remains, as a potentially unstable mass is still present at the top of the slope (Fig. 7).

Fig. 7 Areeiro roundabout slope: **a** May 2011 failure, **b** April 2010 failure and **c** global view in May 2011. At left is the Areeiro roundabout slope with accumulation of fallen blocks of the 2011 slide. At centre top, it is visible the scar of the slide surface of 2010. At far right it is visible the Areeiro School slope. The grey mudstone layer responsible for the slides is highlighted by the dashed line. A₁ and A₂ – terms of the “Grés de Silves”

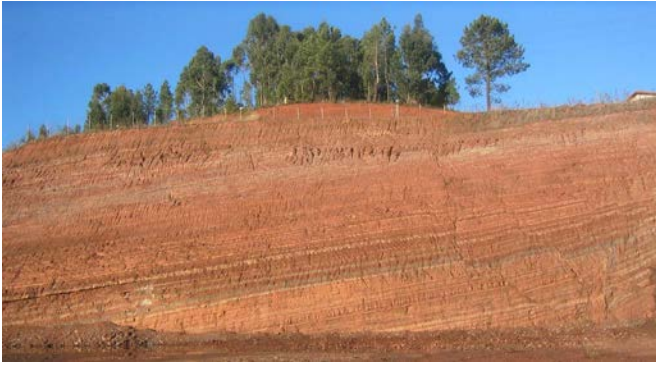
In contrast to the successive instabilities which occurred on the east side of the valley, no significant mass movement was observed on the west side, despite the fact that this >20 m high slope is the highest in the area (Fig. 8). Only minor rockfalls were observed after intense or prolonged rainfall and some water washing of the slope face. The general orientation of the slope is N15°-45°W; 10°-27°SW, although steeply dipping faults approximately perpendicular to the slope face result in some variability in the bedding orientation, particularly close to the faults. The absence of stability problems may be explained by the fact that the bedding dips into the slope. The upper part of unit A2 (Conraria formation) and the lower part of unit B1 (Castelo Viegas Formation) outcrop in this slope (Fig. 2, 8).

Fig. 8 View of the west cut slope of Quinta da Portela, around 20 m high, without any major instability features

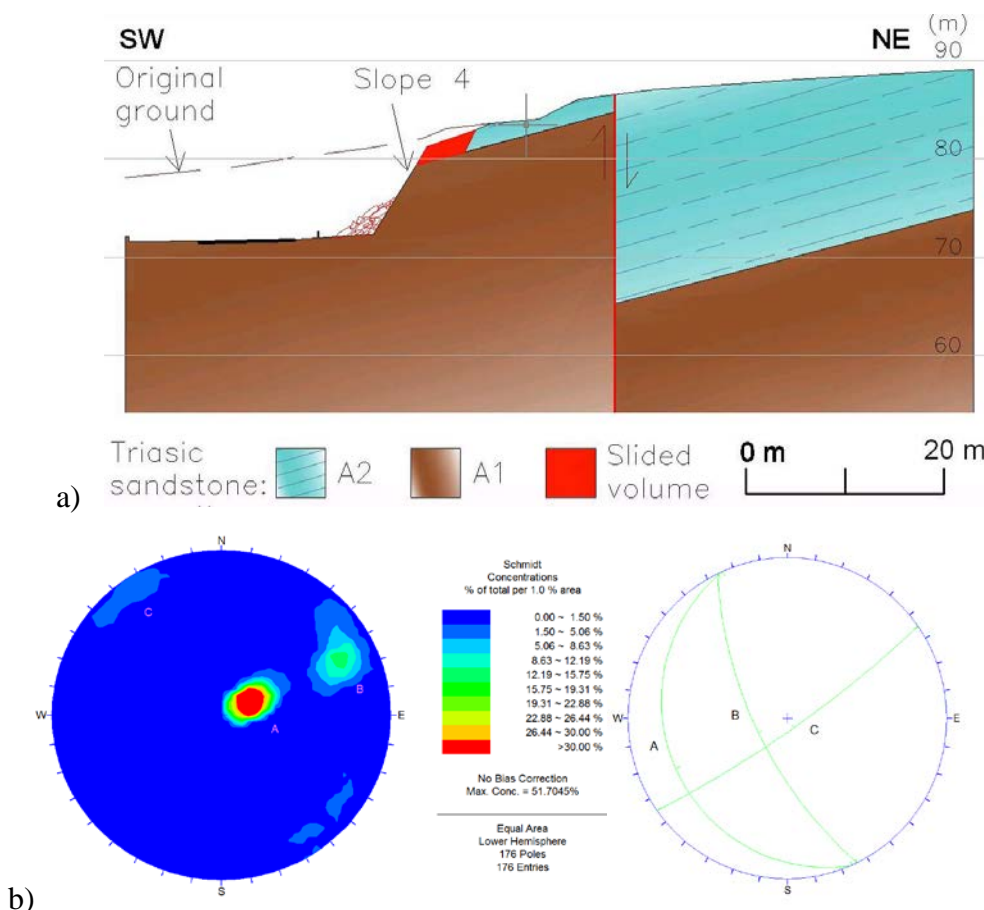
Slope 4 is mainly formed of sandstone layers with rough surfaces. The discontinuities have a friction angle of $>35^\circ$ which inhibits slope failure. However, the mudstones may have a residual friction angle of $< 15^\circ$ (Table 6), allowing the development of the planar failures observed in previous movements (Figure 16).

There is also the possibility of wedge failure due to the intersection of the A and C discontinuity sets, although the latter are less frequent. The use of the refinement to the Markland (1972) test proposed by Hocking (1976) shows that planar failure is more likely to occur than wedge failure, as confirmed by “in situ” observations.

Fig. 16 Areeiro roundabout slope (slope 4): **a** slope cross section and **b** stereonet plot of poles and density contour diagram using the program Dips. A, B and C discontinuity sets

As landslides may occur in areas that show no evidence of instability, the areas adjacent to the Areeiro's School and to the Areeiro roundabout warrant special attention including detailed monitoring of the slope. In the Areeiro cut slopes, some stabilization measures are recommended to avoid dilation of the mudstone and to drain the groundmass to avoid the build-up of pore pressures.
