IMAGE IN CARDIOLOGY

Looking in the mirror: An unusual optical coherence tomography image

Patrícia Marques-Alves^{a,b,*}, Luís Leite^{a,b}, Vítor Matos^a, Lino Gonçalves^{a,b}

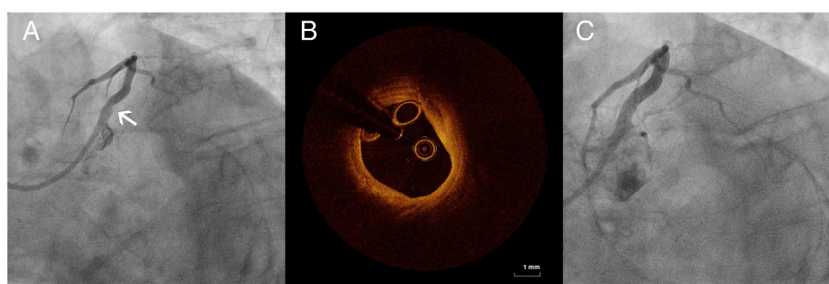
in the LAD. Withdrawal of the jailed D1 guidewire caused a deep intubation of the guide catheter into the LAD. The subsequent angiogram was notable for a suspicious haziness proximal to the stents (Figure 1A, arrow). We decided to perform optical coherence tomography (OCT) of the LAD. However, the catheter did not pass further than the proximal

Figure 1 (A) Angiography showing a suspicious haziness proximal to the stents (arrow); (B) optical coherence tomography image of the proximal left anterior descending artery (proximal to the stent), with a suspicious circular image; (C) final angiographic result, after angioplasty with a 3.5 mm×18 mm drug-eluting stent proximal to the previous stents.

segment, showing a conspicuous circular image (Figure 1B). Meanwhile, the intravascular ultrasound catheter was able to progress and did not show the image, only malapposed struts. Angioplasty proximal to the previous stents was performed with implantation of a 3.5 mm×18 mm DES, with a good final angiographic result (Figure 1C). In subsequent OCT images the circular image had disappeared.

We postulate that the intubation of the guide catheter during retrieval of the jailed guidewire damaged the proximal stent struts. Thus, the circular OCT image was of the OCT catheter itself, which was folded by attempts to pass
