# The Impact on Structures of the *Pedrógão Grande* Fire Complex in June 2017 (Portugal)

**Abstract:** On 17 June 2017, one of the most dramatic and destructive wildfires in Portugal's History started, formed by a complex of at least five wildfires that merged together burning more than 45,000 hectares. In its aftermath, 66 persons lost their lives, most of them trying to run away from the fire, more than 250 were injured, and over 1000 structures (including 263 residential homes) were damaged or destroyed, with direct losses estimated at around 200 million euros. Shortly after the fire was extinguished, and as part of a larger analysis, the authors performed exhaustive field work to assess the fire impact on all manmade structures in the area of the *Pedrógão Grande* fire. A specific geodatabase was built, accounting for an extensive set of parameters aimed at characterizing: (i) The structure, (ii) the surroundings of the structure, and (iii) the arrival and impact of the fire. A total of 1043 structures were considered for the analysis, mostly support structures, like sheds or storage (38.6%), but also around 25% of dwellings (13.3% primary and 11.9% secondary). Regarding the i

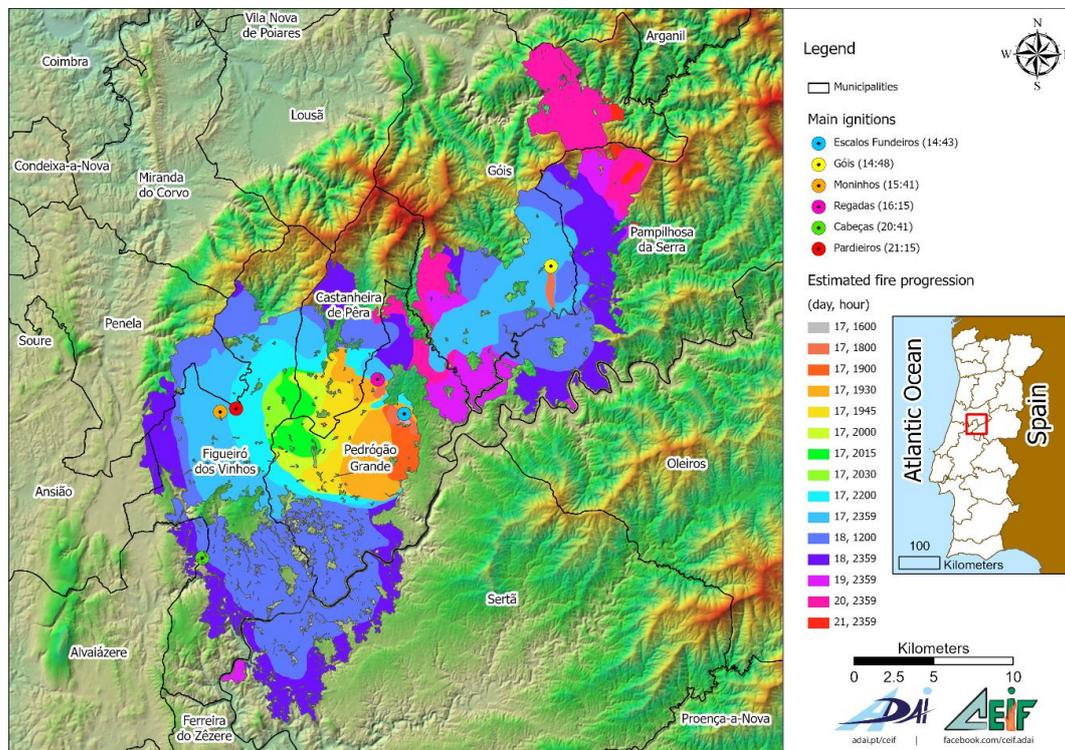
**Figure 1.** Estimated fire progression and main ignitions.

the consultation of a large number of documents. The result of fire growth is shown in Figure 1, as isochrones of fire spread.

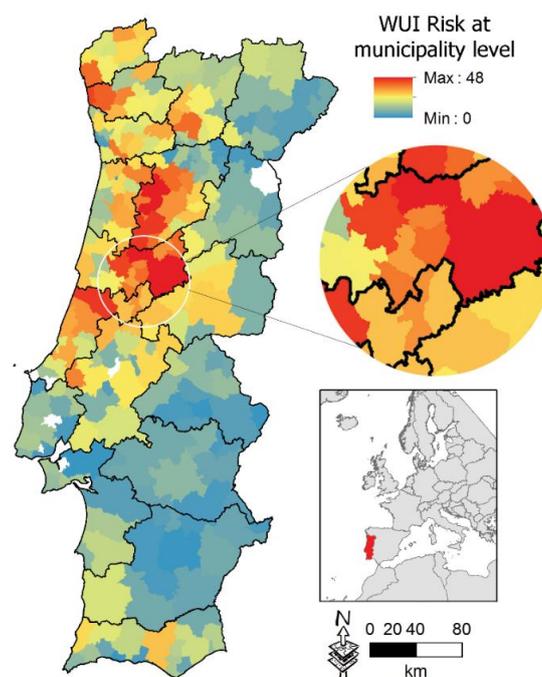
**Figure 2.** Characterization of wildland urban interface (WUI) fire risk in Portugal at Municipality level (adapted from [4], with the area of the *Pedrógão* fire highlighted).

The area inside the white circle, enlarged at the right, is where the *Pedrogão* fire complex took place, and it corresponds to areas with very high WUI fire risk, some of them the highest found in the whole Country. Throughout this region, [4] identified some common problems, namely: Isolated houses within forest areas (high risk); interfaces of small settlements with forested areas (high risk); interfaces of small settlements with shrubs (except *Castanheira de Pera*) (moderate risk); and interfaces of settlements in irrigated agroforestry mosaic (moderate risk).

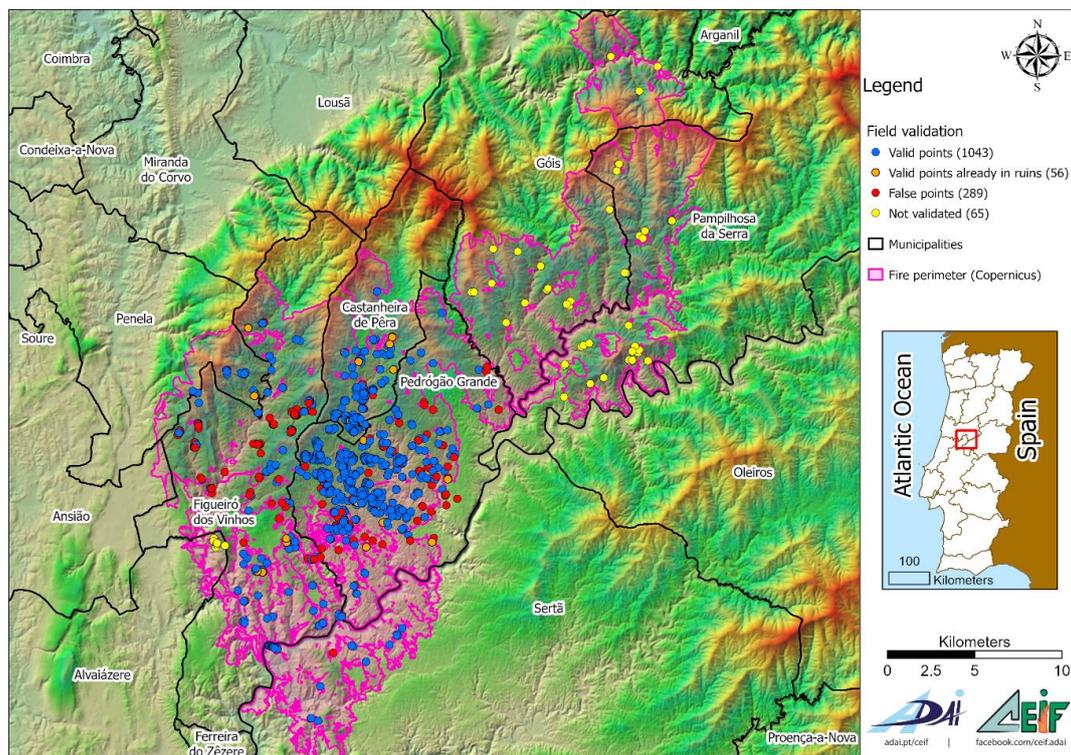
**Figure 3.** Location of all points visited (blue, red, and orange) and not visited (yellow).

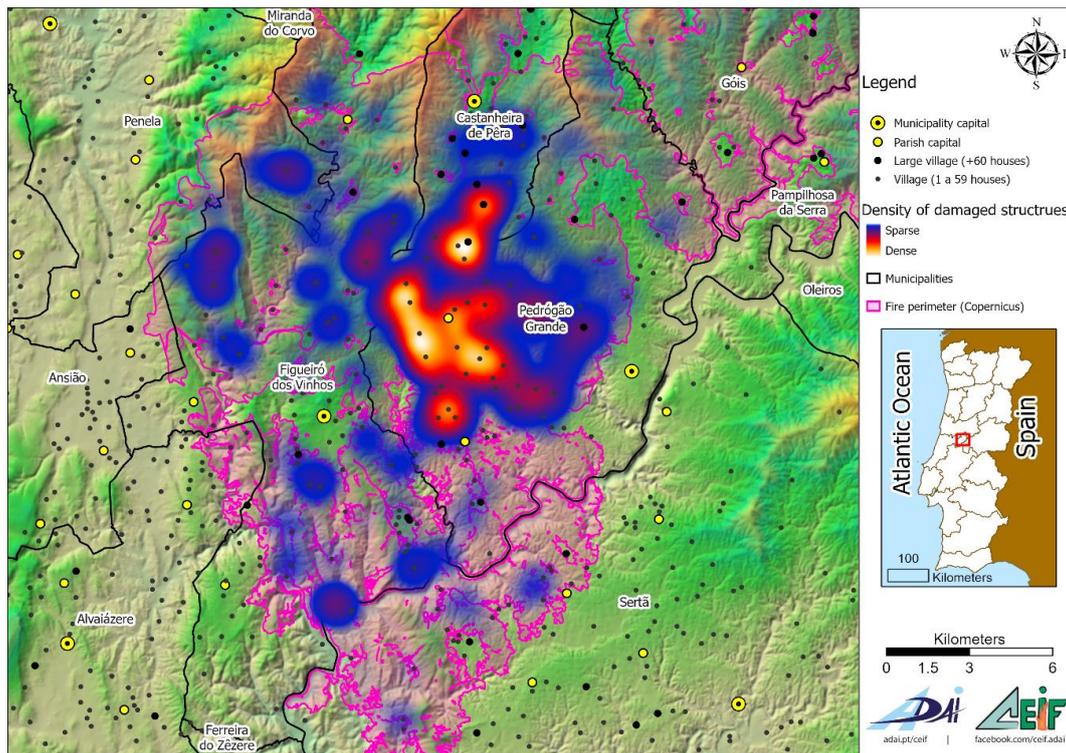
Figure 4. Heatmap representing the density of structures damaged by the fire.

The concentration of damaged structures in the time and place of the most extreme fire propagation was obvious from the beginning. We obtained 464 answers (44.5%) pertaining to the date and time of arrival of the fire, and from these, 388 placed it between 18:30 and 20:30 of 17 June. Figure 4 is a close up on the area of the analysis and graphically presents the density of damaged structures, where the warm red/yellow colors show the concentration of the destruction in the western area of *Pedrógão Grande* and southern of *Castanheira de Pera*. In *Figueiró dos Vinhos* the damage was more scattered.

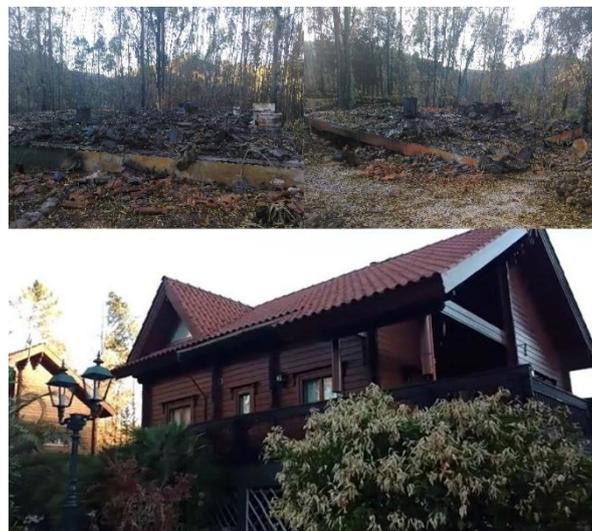
**Figure 5.** Example of totally destroyed wooden houses. The picture below refers to one of the destroyed houses before the fire, and it was taken from Google Earth Street View.

The typical construction in Portugal uses concrete and clay bricks, here identified as masonry, but in many regions either old houses or newly reconstructed ones can also be made of stone, or a mix of both. This is confirmed by the results of Table 6, where we see that more than 90% of the affected structures are built with one of these two materials. Wood construction is not very common, especially in houses, and we can see that all wooden structures affected by fire were totally destroyed (example in Figure 5).

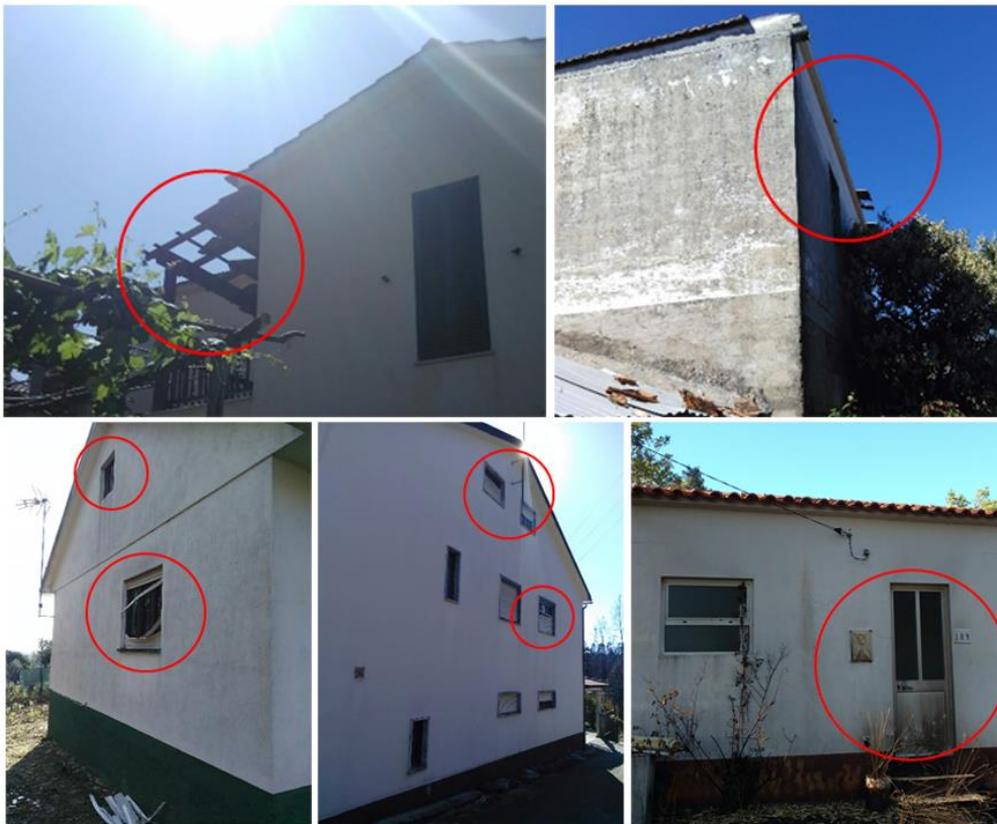
**Figure 6.** Details of some elements that were damaged by the fire but with no ignition to the house.

fact that 38 structures suffered damage but did not ignite. These damages are mostly associated with the strong wind and extreme heat that accompanied the fire. We observed damaged roofs, windows, window blinds, or other small wood or plastic elements, as seen in Figure 6.

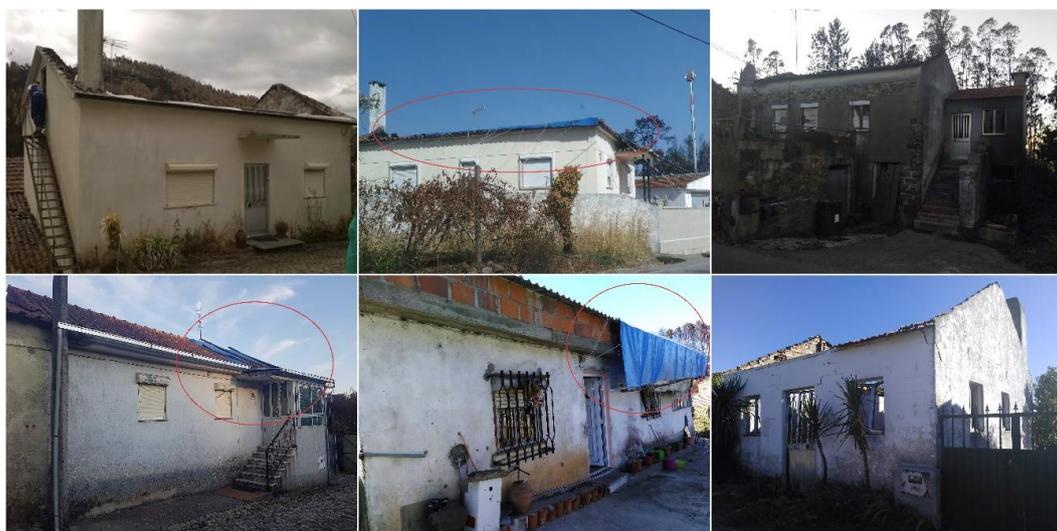
**Figure 7.** Example of houses that had ignitions through the roof.

Regarding ignition location (Table 11), most of them were in the roof of the structures (61.8%, Figure 7). These ignitions were of different nature: (i) Firebrands deposited in vulnerable parts of the roofs, either where there was accumulation of fuels (leaves, twigs, etc.), or where there were structural defects, leaving sensitive elements visible (raised tiles, broken vents, holes, etc.) and (ii) the wind that was felt during the fire raised the roofs or part of them, regardless of their state of conservation, or construction materials (tiles, metal sheets, wood), leaving the interior exposed.

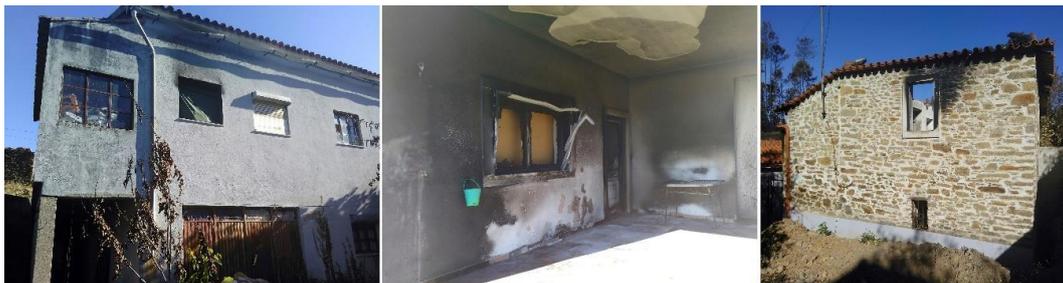
**Figure 8.** Example of houses that had ignitions through the windows.

The windows were the second element most exposed to ignition, although with a much lower value (16%, Figure 8). We mainly found cases of old windows, sometimes broken, and many structures where the windows had no glass. These are mostly related to support structures, not to housing. Another aspect that deserves to be highlighted is the existence of vents, especially in older houses, without particle retention systems, which are a point of entry for firebrands (19 cases).
