Article

# Mechanical and Typological Characterization of Traditional Stone Masonry Walls in Old Urban Centres: A Case Study in Viseu, Portugal

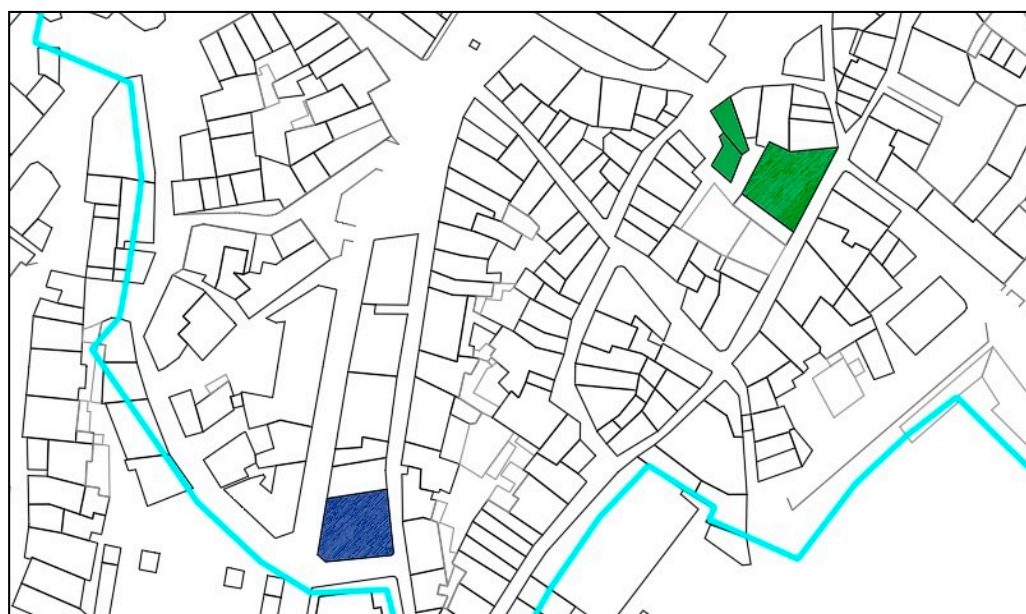
**Figure 2.** Buildings studied in this campaign: Orfeão de Viseu (green) and Águas de Viseu (dark blue). The light blue line marks the old urban center’s limit (adapted from map kindly made available by the Viseu Urban Rehabilitation Society Viseu Novo).

Figure 2 shows the location of these buildings in the old urban center of the city. In the following subsections, each building is briefly described, and the geometrical and material characteristics of the walls studied in each one of them are presented.

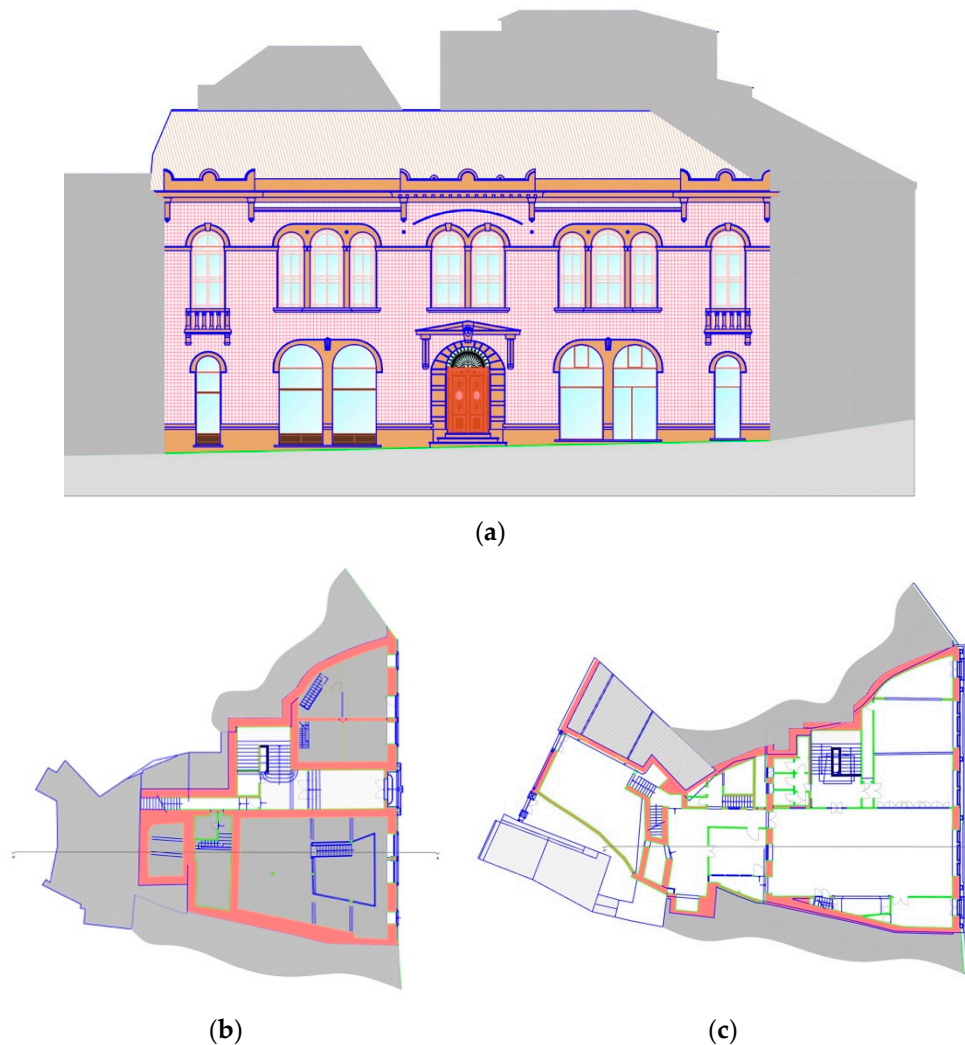
**Figure 3.** *Orfeão de Viseu*: (a) main façade of the building, (b) plan of the ground floor and (c) the first floor.

The building located in the number 149 of Rua Direita (the ancient commercial artery in the city) housed between 1955 and 2006 the headquarters of *Orfeão de Viseu*, a cultural society dedicated to arts and music. Structurally, the building follows the traditional constructive technology, with load-bearing stone masonry walls and timber floors and roofs. Of unusually large dimensions for the area in which it is located, it is known that it was partially rebuilt after a fire in 1926 [9]. Figure 3 presents the main façade of the building, as well as the plans of the ground floor and the first floor.

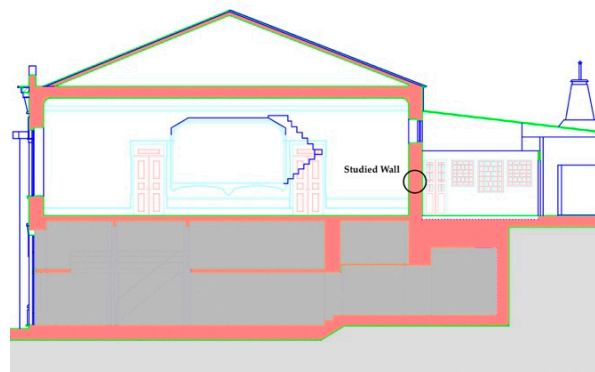
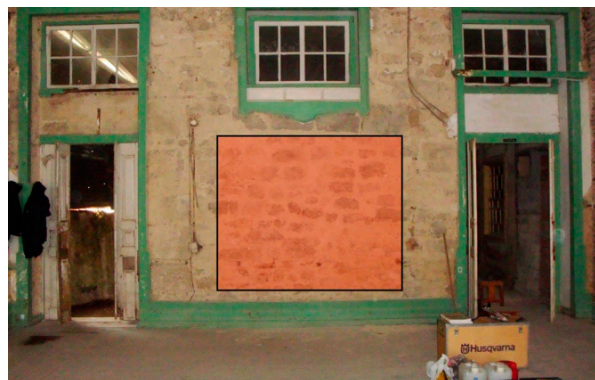
**Figure 5.** Identification of the studied wall. (a) location in the building; (b) testing area.

A 50 cm thick interior load-bearing wall, located in the main hall and parallel to the main façade, was studied in this building, Figure 5a. As can be seen in Figure 5b, stone masonry was visible without the need to remove any plaster. The masonry consists of gray granite stones, with both rectangular and square shape, and cream color mortar. In general, a length of around 70 cm, for the biggest rectangular stones, and around 20 cm, for the square ones, can be observed. Rectangular stones present a length/height ratio of approximately 3. The presence of wedges was not significant.

Due to access limitations, it was not possible to observe the inner side of the wall, and thus it was not possible to infer about the existence of multiple leaves and/or through stones. It must be pointed that, due to repointing, the apparent dimension of the stones may not correspond to their actual dimension, as a result of mortar overlapping along their contour. As for the cross-section, the wall was found to be composed of two leaves, with a poor to reasonable degree of connection. The existence of an inner core, of weaker quality, was in any event ruled out. This last conclusion was further reinforced by the observation, resorting to videoscopy, of another wall's interior in the same room.

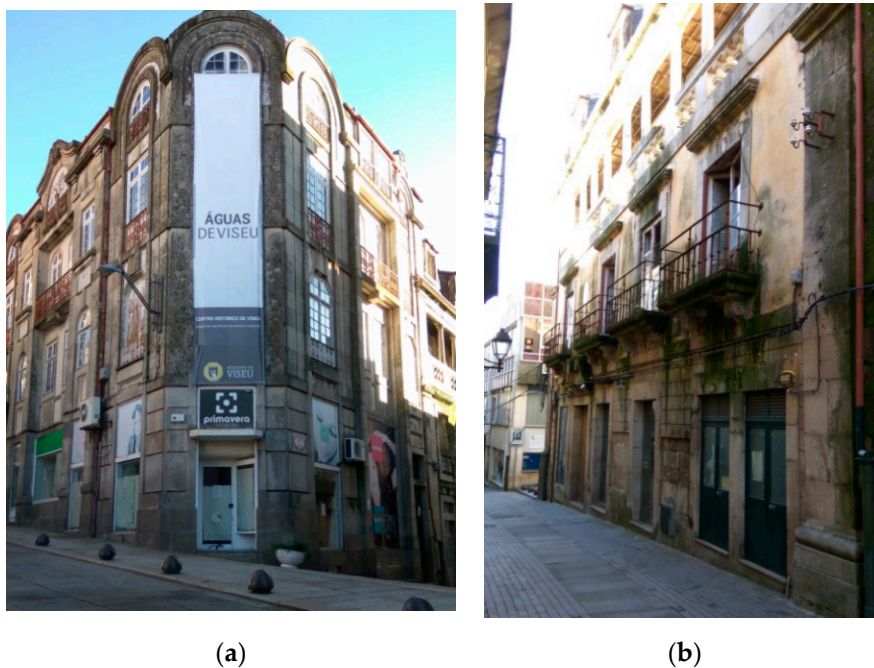
**Figure 6.** *Águas de Viseu*: (a) view to Rua do Comércio; and (b) view to Rua D. Duarte.

The building dates back to the 1920s, and has three fronts, facing Rua Dr. Luís Ferreira (the ancient Rua do Comércio), Rua D. Duarte and Travessa de São Domingos (Figure 6). Besides the ground floor, it counts three floors and an underground basement.

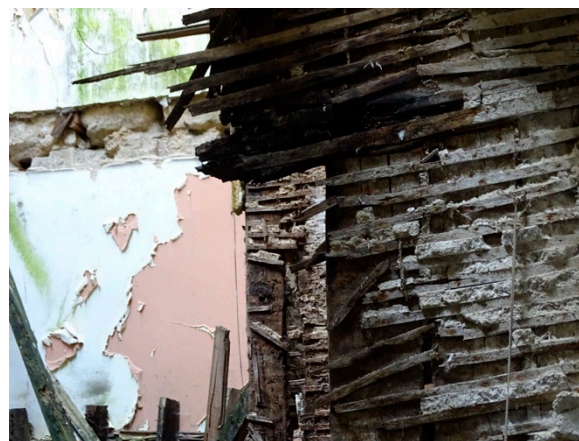
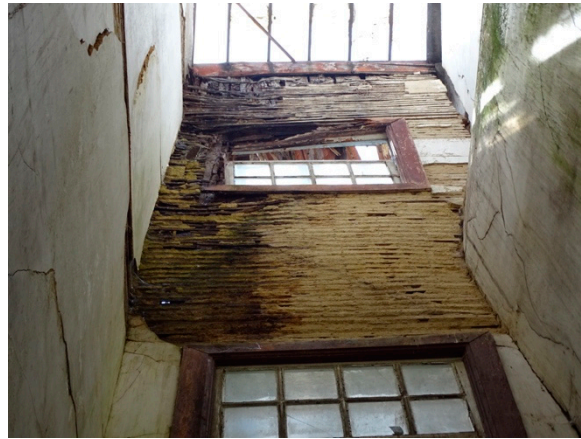
**Figure 7.** Severely decayed structural elements.

Despite it being classified as a structure with “relevant architectural and heritage value”, the building is presently in an advanced state of degradation, see Figure 7.

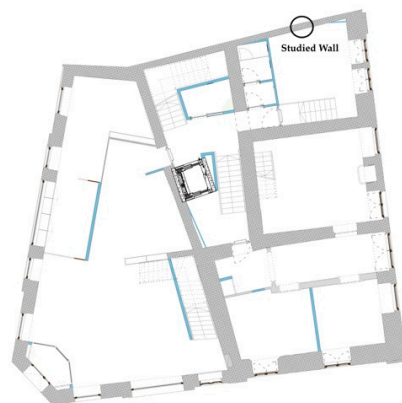
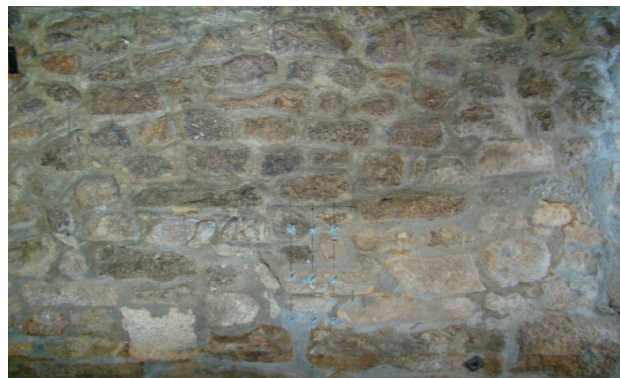
**Figure 8.** *Águas de Viseu*: (a) building plan with the identification of the studied wall; (b) view to the wall.

As in the previous case study, an internal load-bearing wall was studied, this time located at the ground floor and perpendicular to the façade facing Rua D. Duarte, Figure 8a. As can be seen in Figure 8b, also in this case, stone masonry was visible without the need to remove any plaster. Due to the presence of different minerals, such as quartz, mica and feldspar, stones present various colors, ranging from gray to yellow and pink. The mortar, of a gray color, appears to evidence recent repointing. Stones were rather irregular, both in shape and dimensions. The assemblage was markedly irregular, at times with stones laid with their larger dimension alongside the vertical. The presence of wedges was not significant.

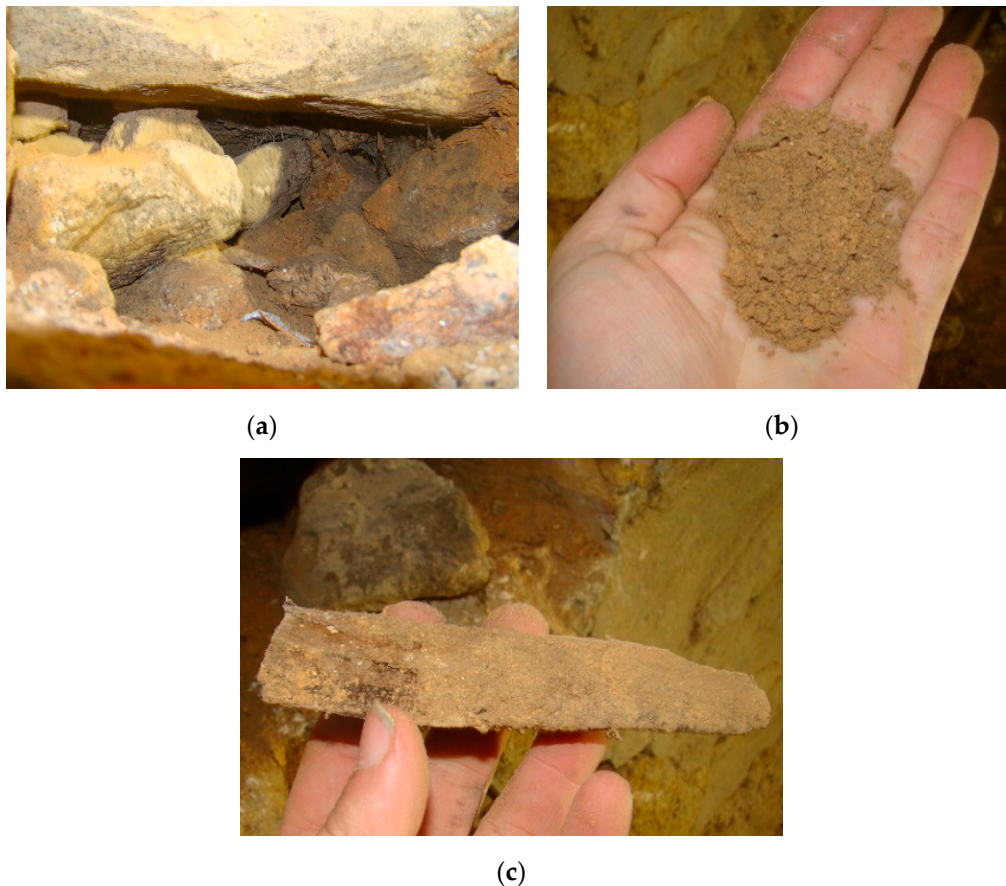
**Figure 9.** Wall's inner core. (a) roughly-shaped granite stones; (b) lime mortar and earth; (c) wood splinters.

The wall was found to be composed of two leaves, with an interior non-cohesive core (*sacco* masonry). Both the interior leaf and the inner core are 25 cm thick. It was not possible to measure the outer leaf thickness, but a 25 cm thickness is equally plausible. A total thickness of 75 cm, at ground level, would then be expected. Regarding the inner core, it was possible to observe that the wall was filled with roughly-shaped granite stones of about 10–15 cm long, laid in a random manner (Figure 9a), linked by lime mortar and earth (Figure 9b). Some small wooden elements, such as wood splinters, were also found in the inner core of the masonry wall, see Figure 9c.

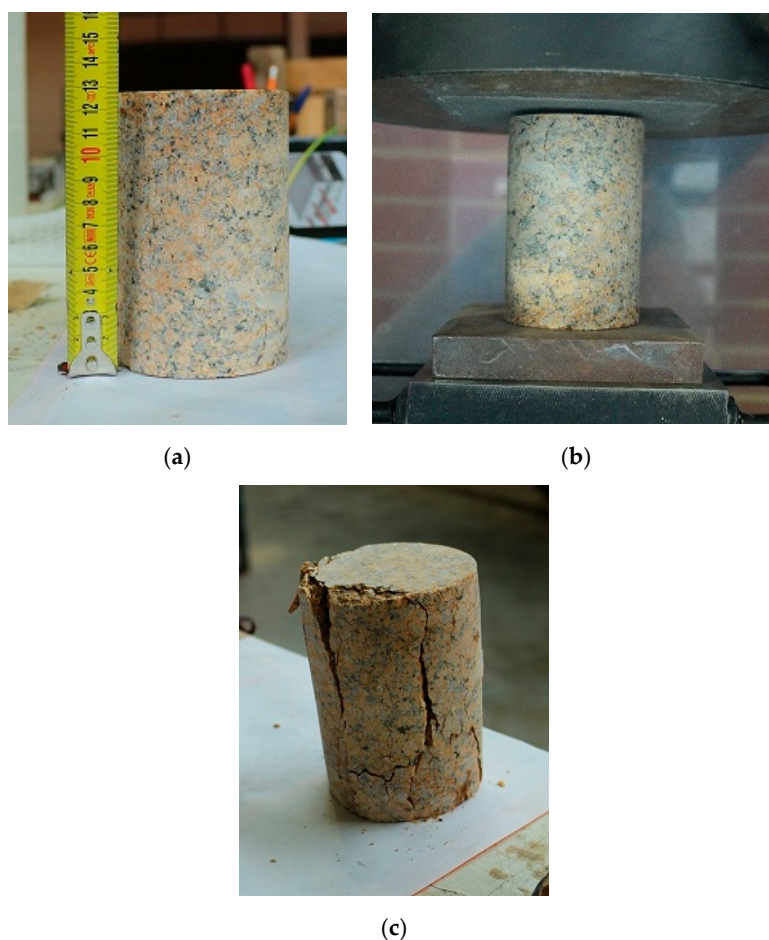
**Figure 10.** Compression test. (a) stone specimen; (b) experimental apparatus; (c) appearance of the specimen after the test.

Figure 10 presents the test sample, the test procedure and the final appearance of the sample after tested. The results obtained in the compressive test are presented in Table 1, where  $L$ ,  $D$ ,  $m$  and  $\gamma$  stand respectively for the length, diameter, mass and specific weight of the test specimen and  $f_{cb}$  is the maximum compressive strength recorded in the compressive test.

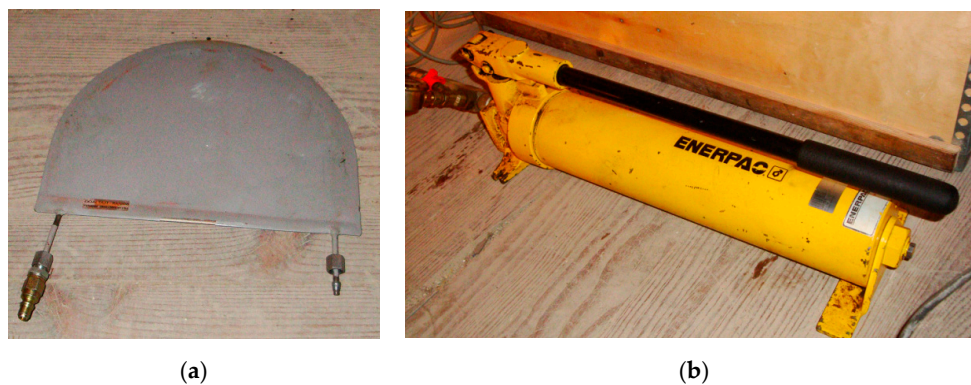
**Figure 11.** Equipment used in this campaign: (a) semicircular flat-jacks and (b) hydraulic pump.

- Flat-jacks: BOVIAR MPA—A semicircular flat-jacks, with dimensions  $350 \times 260 \times 4$  mm, and maximum service pressure 60 bar, Figure 11a. According to the calibration certificate, a  $k_m$  value of 0.902 was assumed for all the flat-jacks used in this campaign.

- Masonry cutting equipment: HUSQVARNA k970—Ring cutting machine, with a 300 mm eccentric diamond blade disk, allowing a cut depth of 270 mm.
- Pressurizing equipment: manual hydraulic ENERPAC pump, with a 500 bar capacity and a 3 L reservoir, Figure 11b. The pressure applied is controlled using a pressure reading manometer. The hydraulic system and the flat-jacks are connected via high pressure hoses.

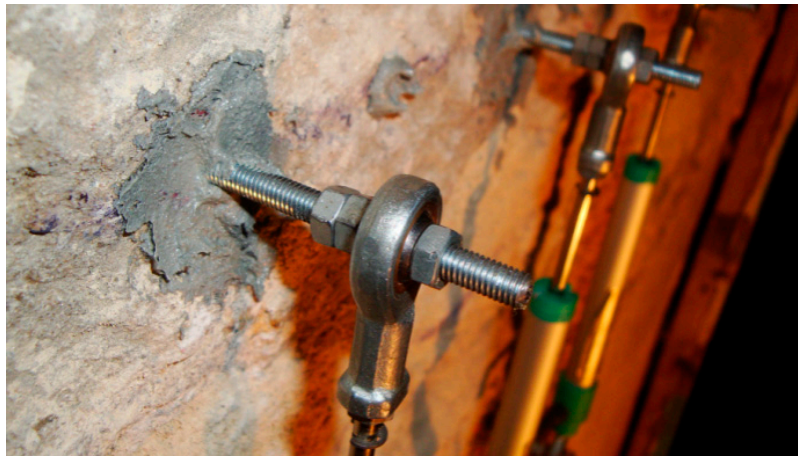
**Figure 12.** Displacement transducers attached to the wall.

- Displacement transducers: GEFTRAN displacement transducers, with a 50 mm stroke, provided with self-aligning ball-joints. The displacement transducers were attached to the masonry by means of 5 mm threaded rods, applied with chemical anchor, at a depth of 50 mm, Figure 12.

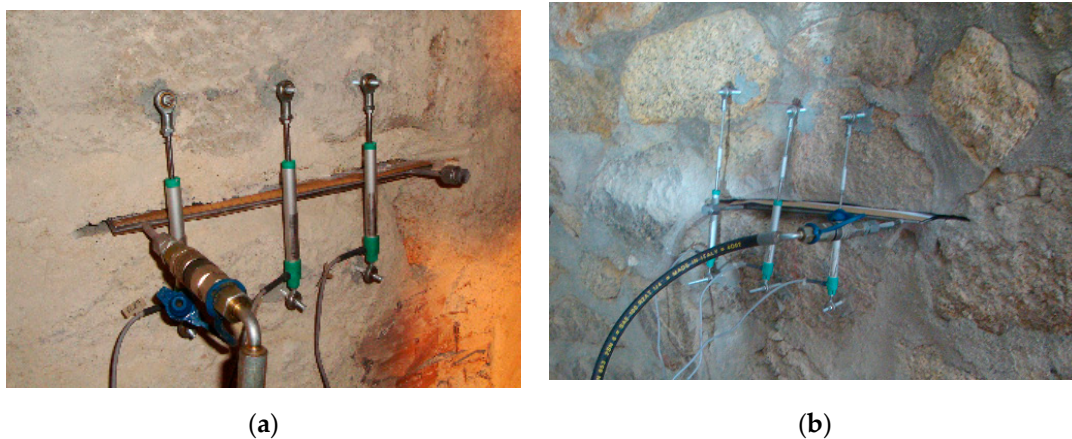
**Figure 13.** Single flat-jack testing: (a) conducted in the Órfeão de Viseu and (b) in the Águas de Viseu (b).

Figure 13 shows the single flat-jack testing. As presented, three vertical reference alignments were considered. In order to estimate the effective flat-jack loaded area, the procedure proposed by Gregorczyk and Lourenço [29] was adopted: a sheet of carbon paper, sandwiched between two sheets of ordinary paper, was placed between the jack's surface and the surrounding masonry (this set was prepared in the shape of the jack). In this way, the areas where the jack comes into contact with the masonry are marked in the paper and can be measured (Figure 14).

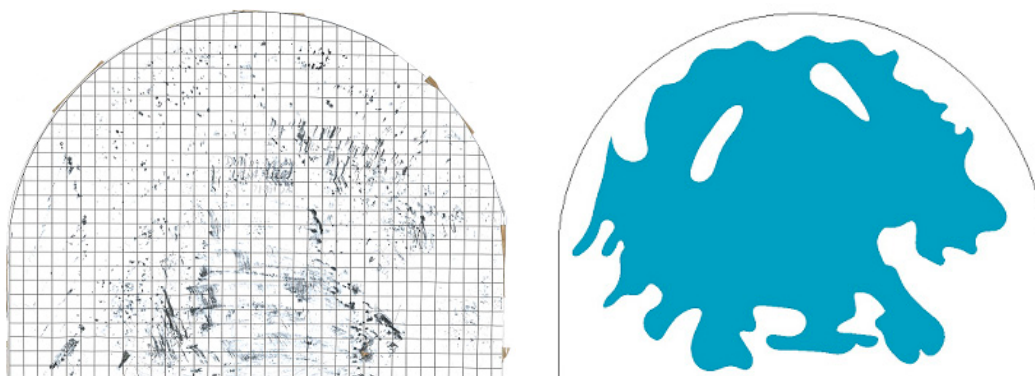
**Figure 14.** Contact area between the flat-jack and surrounding masonry.

Due to the manifest poor condition of some of the carbon papers after removing of the flat-jacks and considering the deformation visible in the flat-jacks, in those cases, coefficient  $k_a$  was estimated based on visual observation.

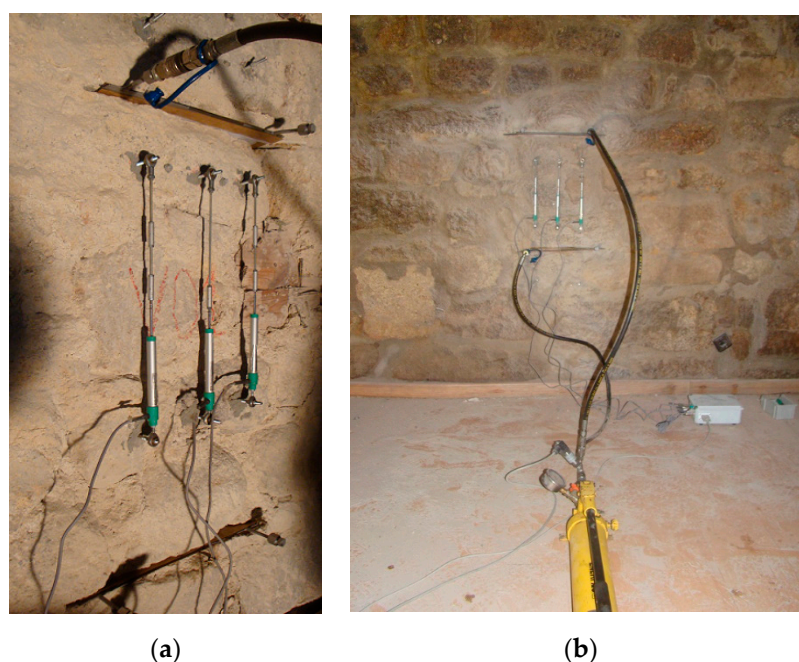
Figure 15. Double flat jack testing conducted in Orfeão de Viseu (a) and in Águas de Viseu (b).

Usually, the initial distance between reference points is not attained simultaneously in the various alignments. This is due, among other factors, to different stone and mortar distributions (areas with a larger proportion of mortar will sustain greater deformation, comparatively to others with a greater quantity of stone). To take this into account, the stress level that restores the initial wall geometry was assumed to be the average of the values that do so in the various alignments. Double flat-jack tests were conducted in the same areas where single flat-jacks had already been conducted, thus taking advantage of the existing cut. Figure 15 shows the double flat-jack testing being conducted.

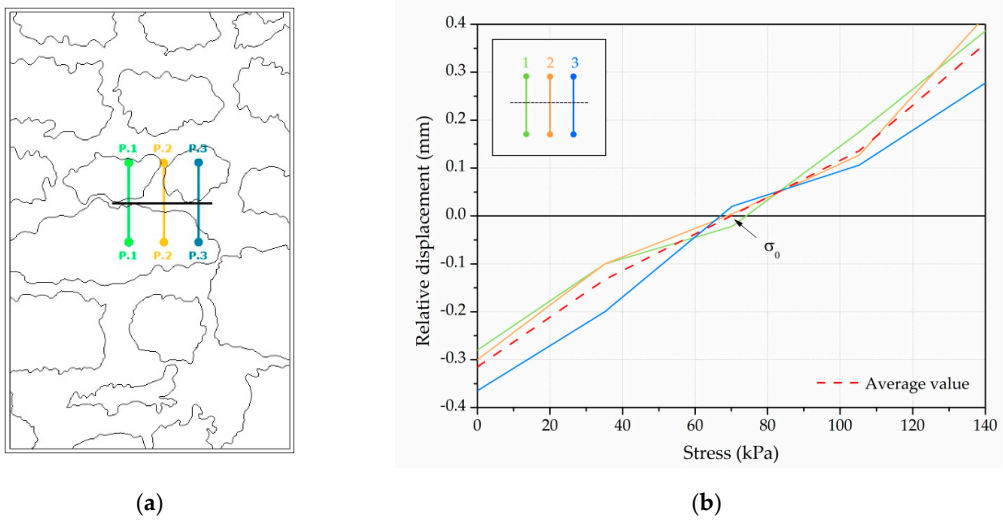
**Figure 17.** Single flat-jack test OS2: (a) identification of the vertical alignments; (b) evolution of the relative displacements for each vertical alignment and estimation of the in-situ stress.

From the displacement results, the in-plane stress is estimated by the average of the four deformation measurements obtained from the three alignments. In the case of the *Orfeão de Viseu*, the low deviance of the displacement readings is a good indicator of the test evolution. Lower values for the single flat-jack test OS1 and OS2 were obtained since the test was carried out on first floor. As for the *Águas de Viseu*, the test was carried out on the ground floor, which is why the in situ stress values are higher than those obtained in *Orfeão de Viseu*. Moreover, in the case of *Águas de Viseu* the displacement readings were more variable.

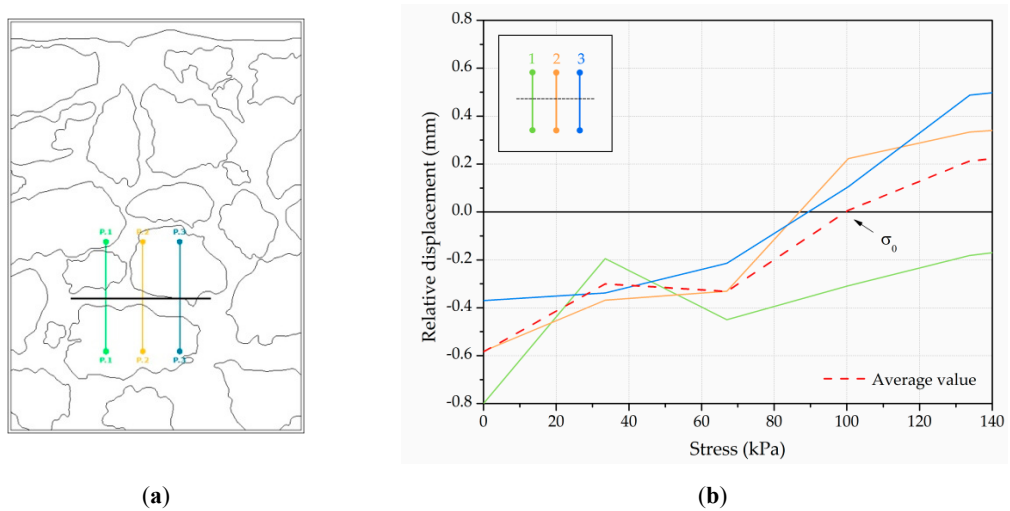
**Figure 18.** Single flat-jack test AS1: (a) identification of the vertical alignments; (b) evolution of the relative displacements for each vertical alignment and estimation of the in-situ stress.

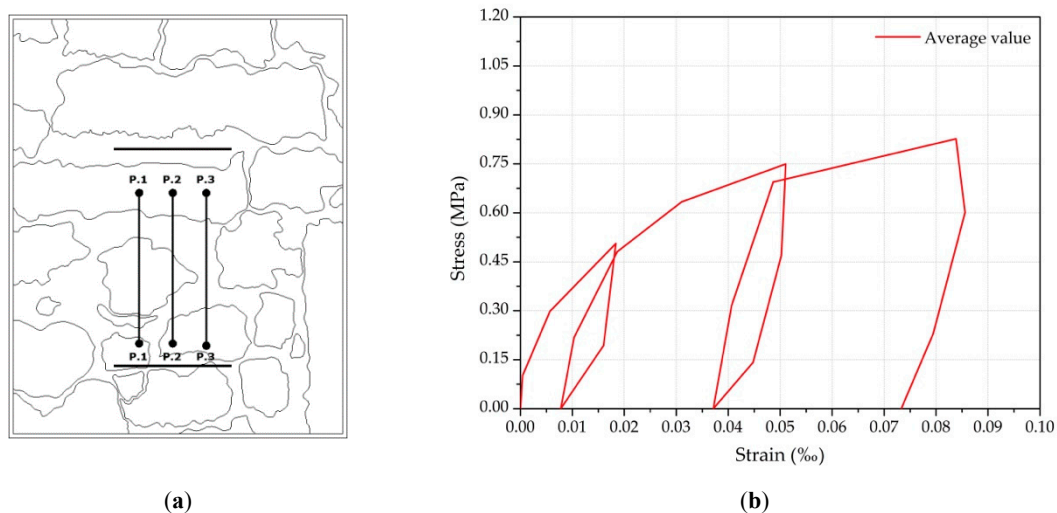
**Figure 19.** Double flat-jack test OD1: (a) identification of the vertical alignments; (b) average stress-strain curve.

Figures 19–21 present the average stress-strain curves obtained for the double flat-jack tests conducted for the same walls and locations. For both buildings, failure was not reached and the maximum stress values attained range between 0.75 to 1.0 MPa. For the three tests, the masonry presented a high percentage of stone in the tested areas and also good fabric, even though there were generalized small dimensions and irregular stone blocks used. In the case of test AD1, this location revealed lower deformability in comparison to the other tested locations.

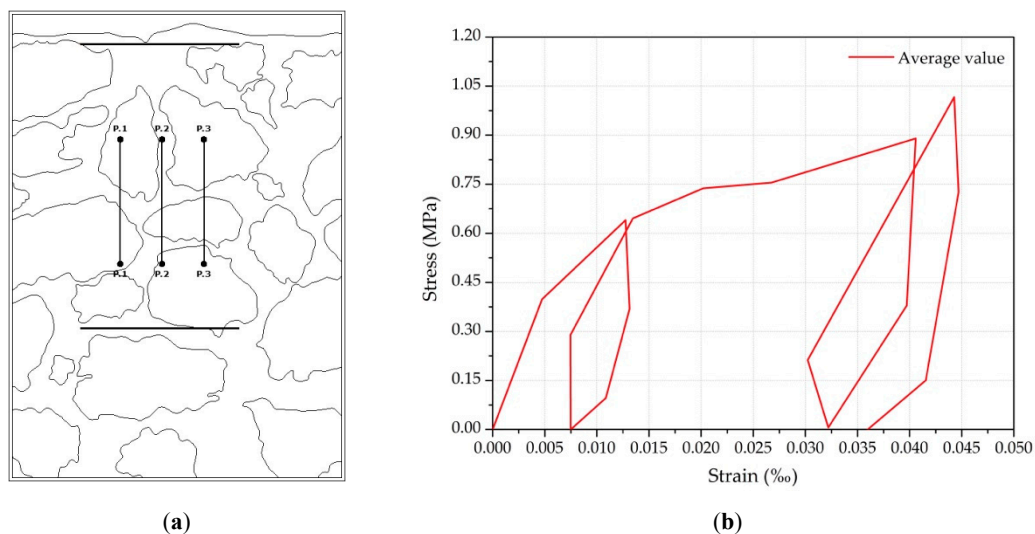
**Figure 20.** Double flat-jack test AD1: (a) identification of the vertical alignments; (b) average stress-strain curve.

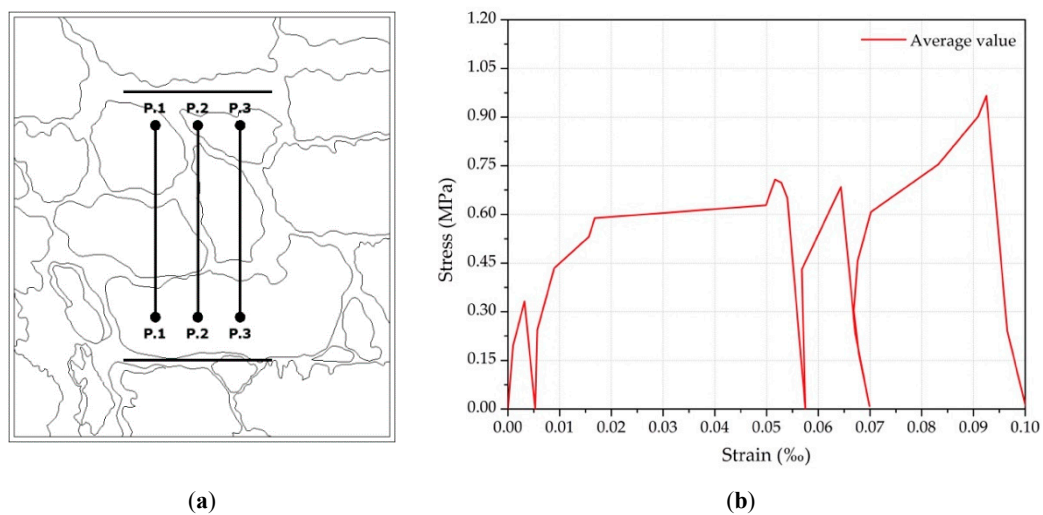
**Figure 21.** Double flat-jack test AD2: (a) identification of the vertical alignments; (b) average stress-strain curve.

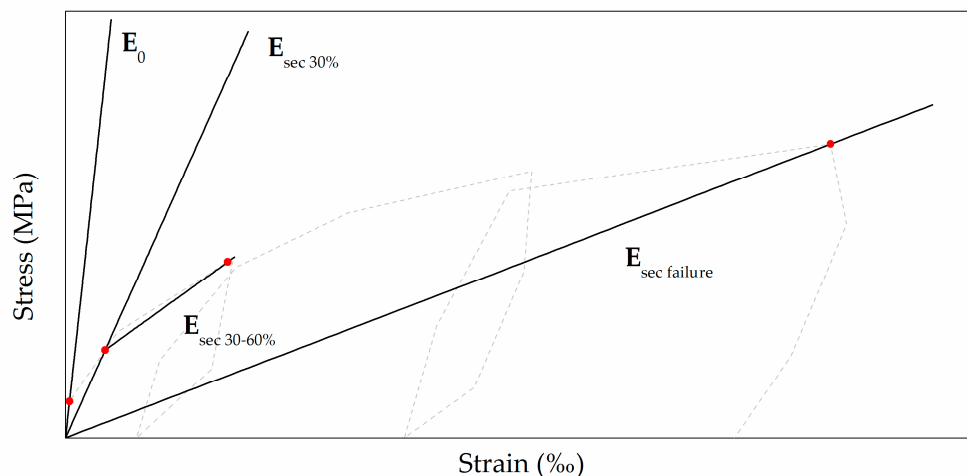
**Figure 22.** Representation of the different Young's modulus.

The Young's modulus was obtained through graphical analysis, taking into account the slope of the stress-strain curves, namely the slope of the secant stiffness. Different portions of the curve (corresponding to different percentages of the maximum strength) can be analyzed, leading to different values for the Young's modulus. Figure 22 presents the different options for evaluation of the Young's modulus that were considered in this paper.
