# Structural rehabilitation of columns with reinforced concrete jacketing

**Strengthening and rehabilitation by reinforced concrete jacketing of columns is assessed, considering different practical aspects: anchoring and slab crossing of the added longitudinal reinforcement, interface surface preparation,**

*Prog. Struct. Engng Mater.* 2003; 5:29–37 (DOI: 10.1002/pse.140)

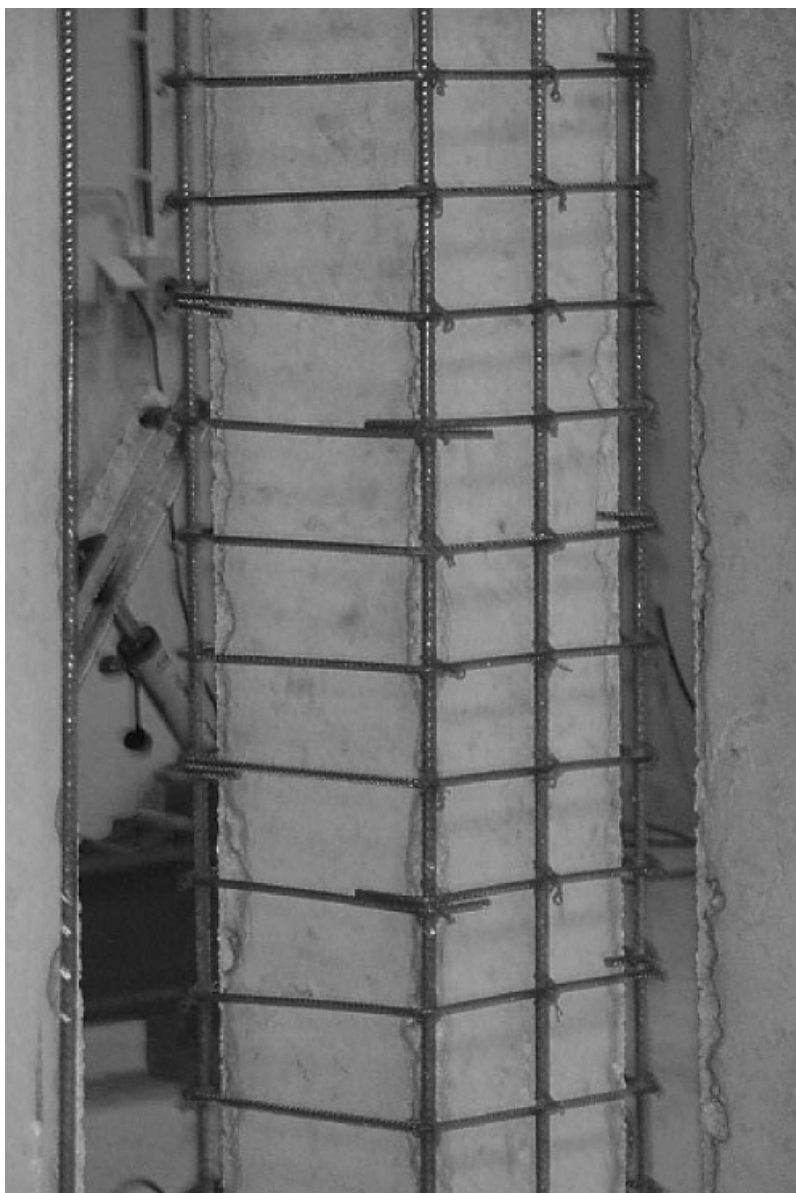
**Fig. 1** Jacketing of RC columns

The objective of this paper is to review one of the most commonly used retrofitting techniques: jacketing of reinforced concrete columns (Fig. 1). This method is evaluated according to different characteristics and, in order to help structural engineers to choose the most appropriate solutions, recommendations are given, based on published experimental research and real case studies.

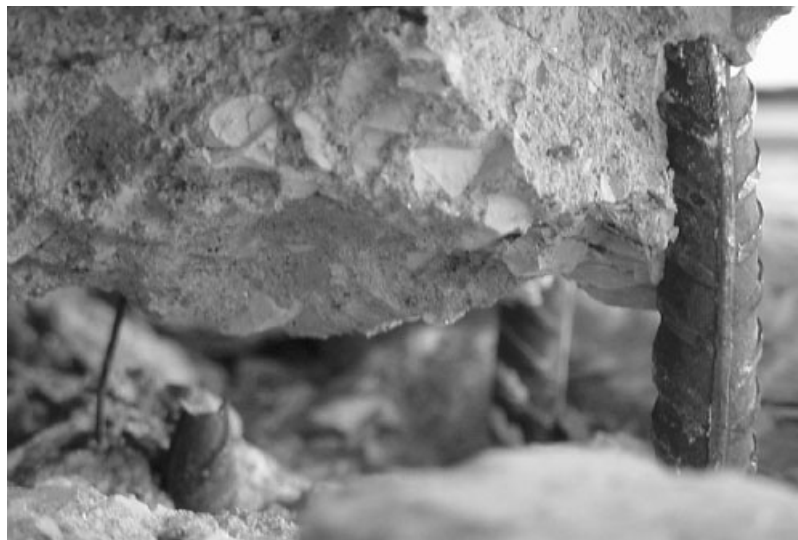
**Fig. 2** Failure of steel bars of the column and slipping of steel bars of the added jacketing

Júlio<sup>[6]</sup> performed tests on RC columns strengthened by jacketing. The steel bars of the added longitudinal reinforcement were anchored to the footing of the original column by a commercially available two-component epoxy resin. The models were submitted to monotonic tests, consisting of a constant axial force combined with an increasing bending moment and shear force. Initially, failure of all steel bars of the longitudinal reinforcement of the original column and slipping of all the corresponding steel bars of the added jacketing were observed (Fig. 2). Pull-out tests were performed to analyse the problem and it was concluded, without any doubt, that the bars slipped because the holes drilled on the footings had not been adequately cleaned<sup>[6]</sup>. The use

of a vacuum cleaner was enough to guarantee the change from slipping failure to tension rupture of the added steel bars.

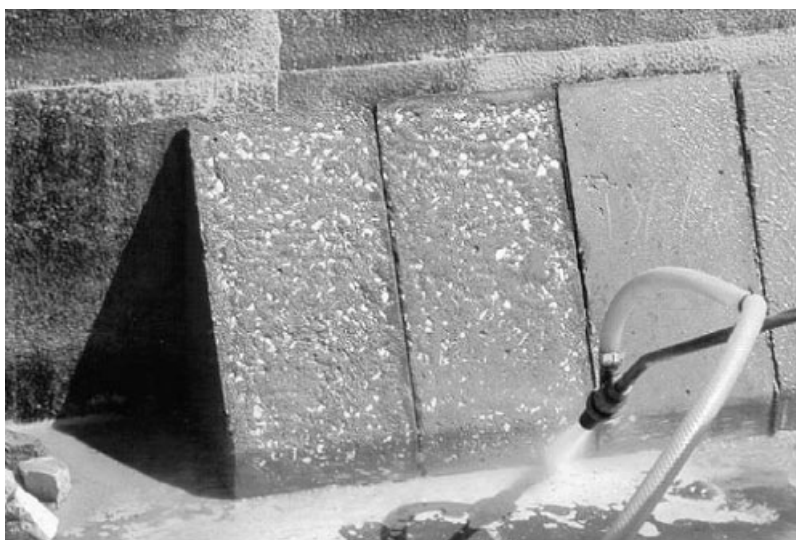
**Fig. 3** Slant shear specimens prepared by sand-blasting

Júlio *et al.*<sup>[16–18]</sup> studied the influence of the interface between concrete layers of different ages on the strength of the joint. The authors performed slant shear tests and pull-off tests on specimens with the interface surface left as cast, prepared by sand-blasting (Fig. 3), prepared by electric hammering and treated with iron brushing. The authors state that

sand-blasting was the most efficient roughening technique of those considered<sup>[18]</sup>.

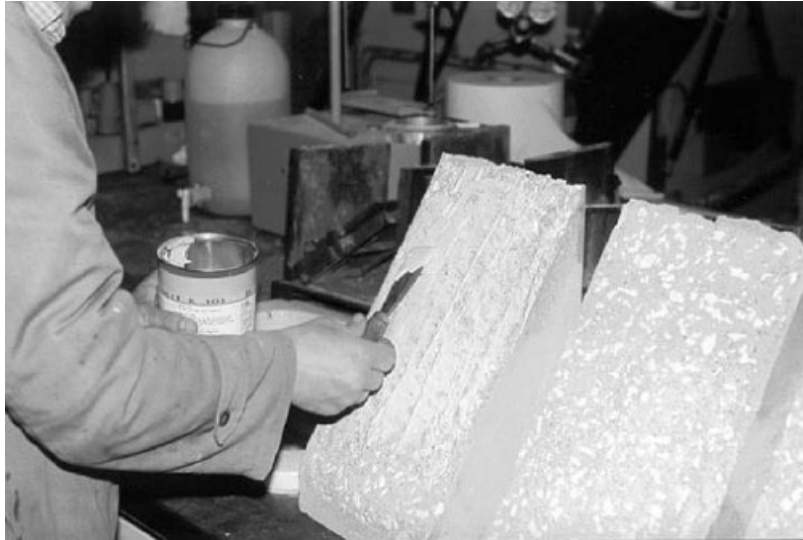
**Fig. 4** Epoxy resin application on slant shear specimens prepared by sand-blasting

Júlio *et al.*<sup>[18]</sup> performed slant shear tests and pull-off tests on specimens, considering different interface surface situations, previously referred to, and also considering the application of a commercial two-component epoxy resin (Fig. 4). The values of the shear and tension strength of the interface reduced when the epoxy resin was applied on the sand-blasted

surfaces, contrarily to what happened when other roughening methods were used.

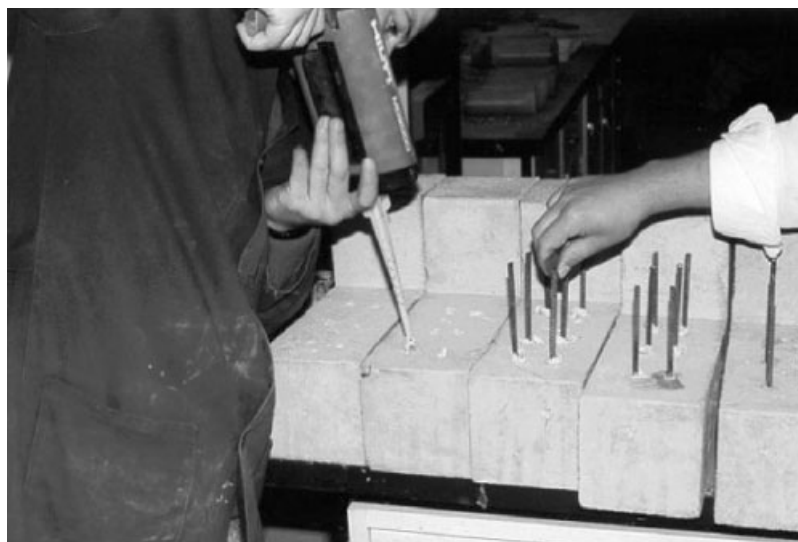
**Fig. 5** Steel connectors epoxy bonded on push-off specimens

Júlio *et al.*<sup>[6,18]</sup> performed push-off tests to analyse the influence of applying steel connectors on the interface strength (Fig. 5). Seven different types of interface surface preparation were considered. It was concluded that adding steel connectors crossing the interface did not significantly increase the debonding force, but increased almost directly the longitudinal shear strength considering slipping; the two commercial products used to anchor the steel connectors proved to be efficient; the fact that steel connectors were added after and not before the substrate was cast did not reduce the joint strength<sup>[18]</sup>.

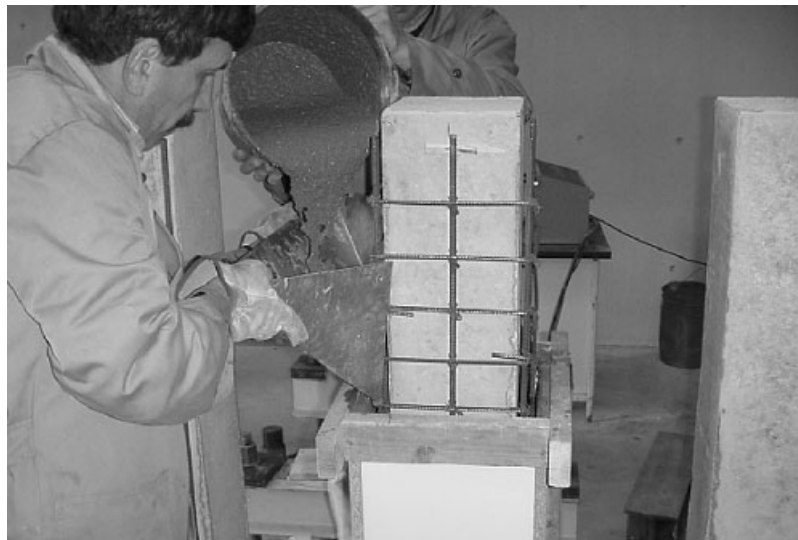
**Fig. 6** Concrete casting of the jacket
