Touristic Rehabilitation of Archaeological Sites in Syria  
- The Aga Khan Foundation Experience between the Past and the Future

Relatório de Estágio em Arqueologia e Território, em Arqueogeografia, orientada pela Professora Doutora Maria da Conceição Lopes, apresentada ao Departamento de História, Estudos Europeus, Arqueologia e Artes da Faculdade de Letras da Universidade de Coimbra.

2018

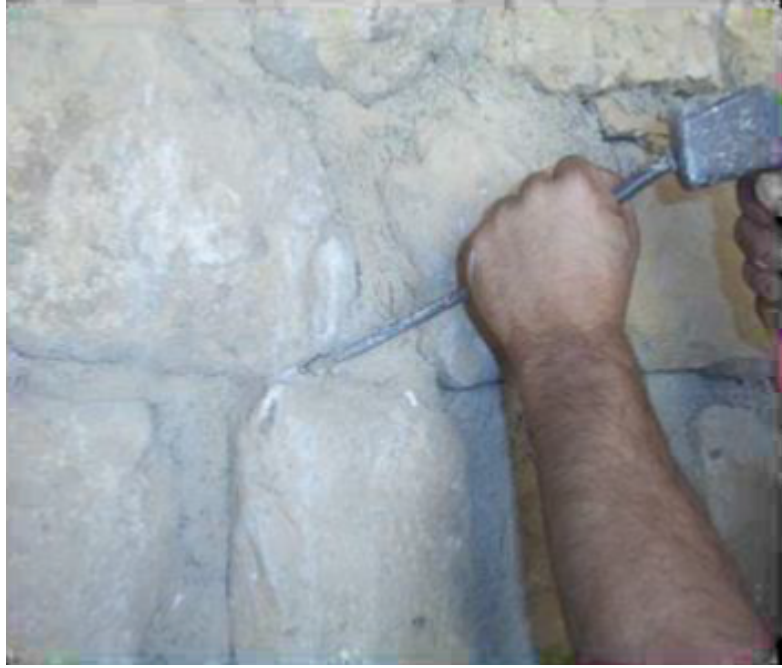
Figure: 3, removing the cement mortar  
(Culture, 2001)

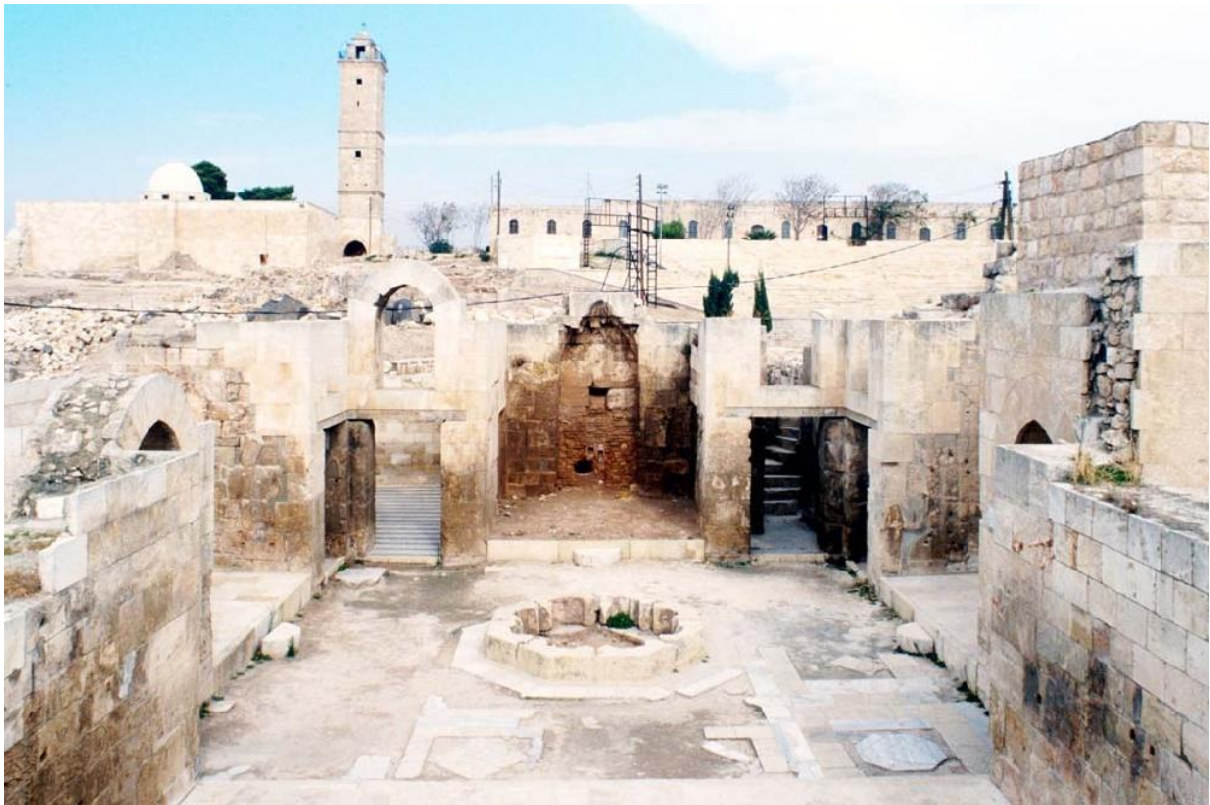
Figure: 5, the pavement of the Ayyubid Palace courtyard, before intervention 2001  
(Culture, 2001)

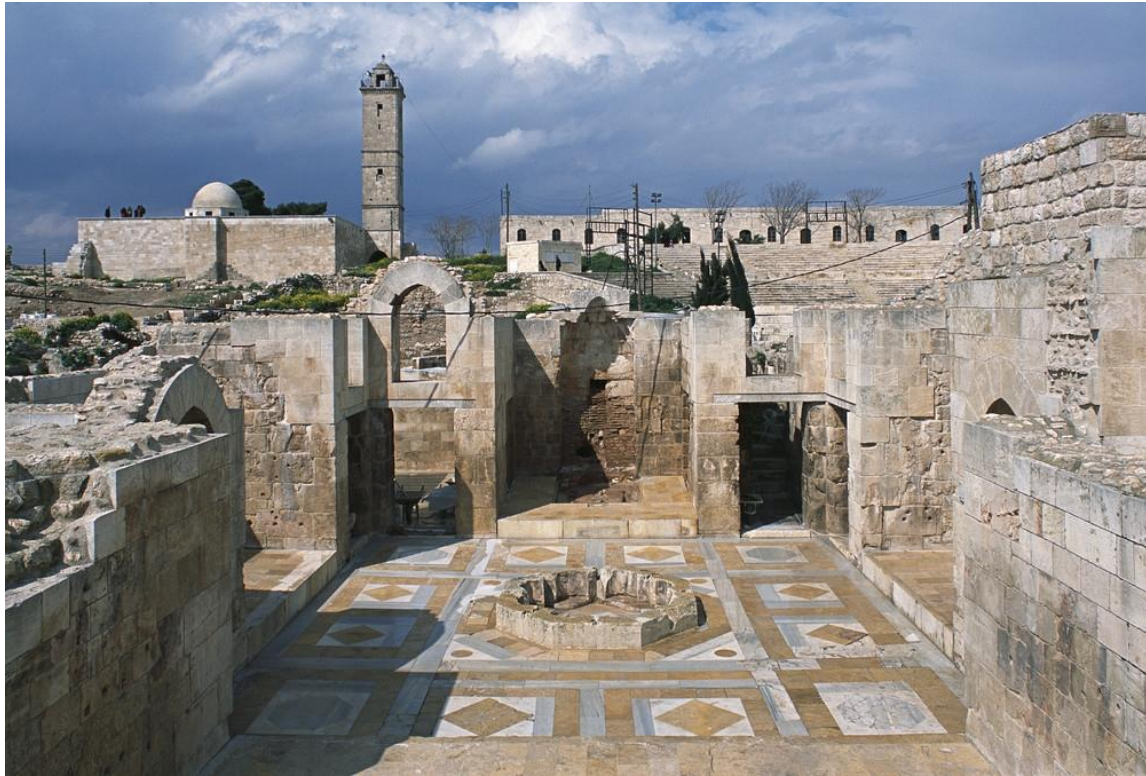
Figure: 6, the pavement of the Ayyubid Palace courtyard, after intervention 2003  
(AKTC, 2007)

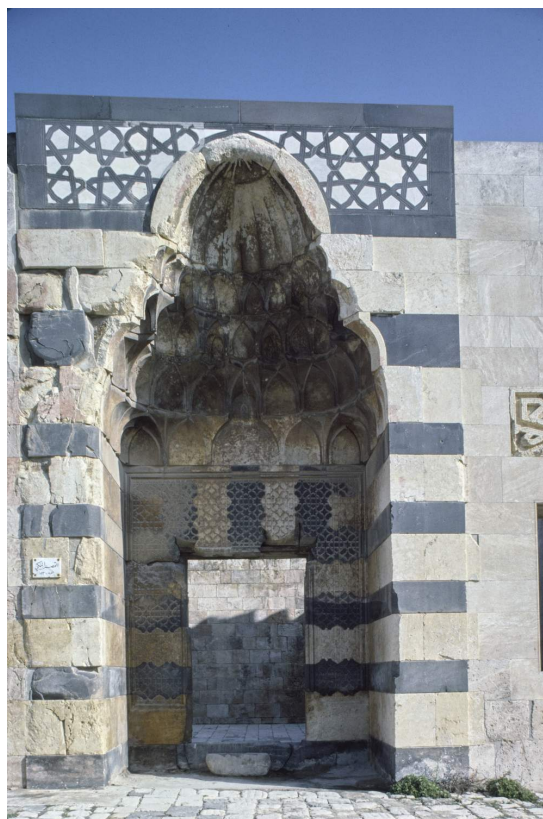
Figure: 7, the entrance portal before restoration  
(Culture, 2001)

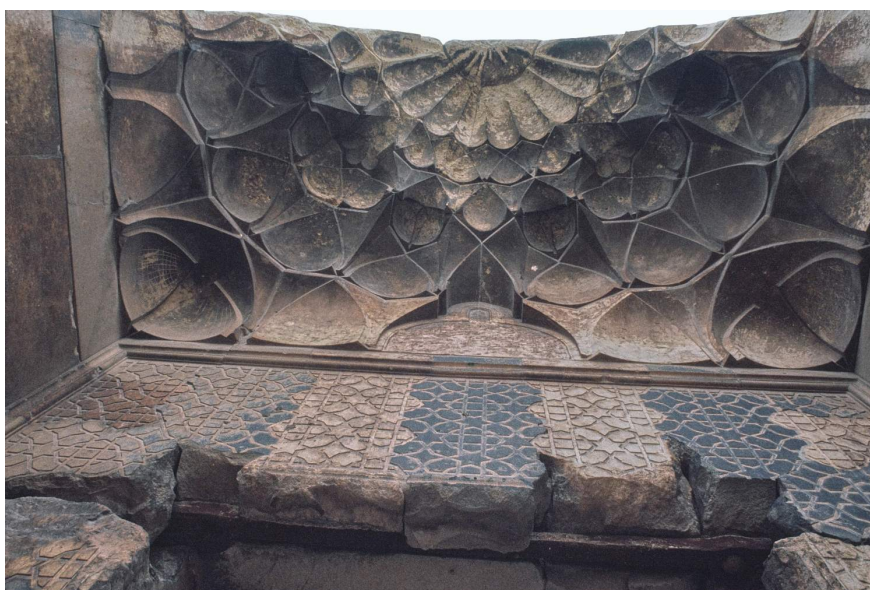
Figure: 9, muqarnas in the portal ceiling  
(Gonnella, 2008)

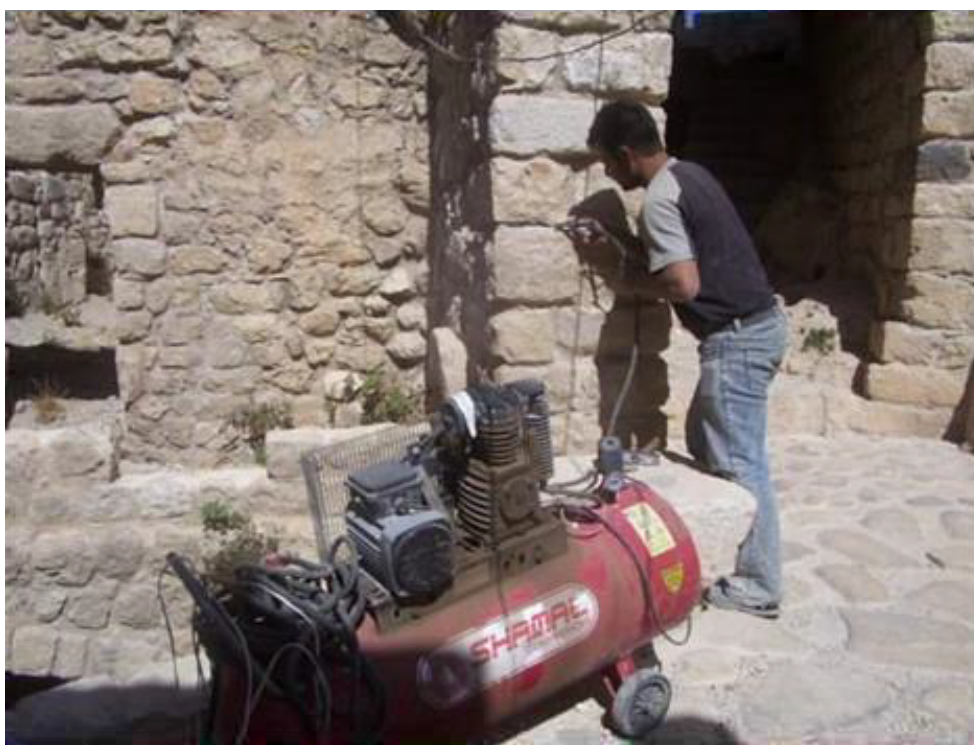
Figure: 10, using aerosol mist spray to clean the stone surfaces  
(Gonnella, 2008)

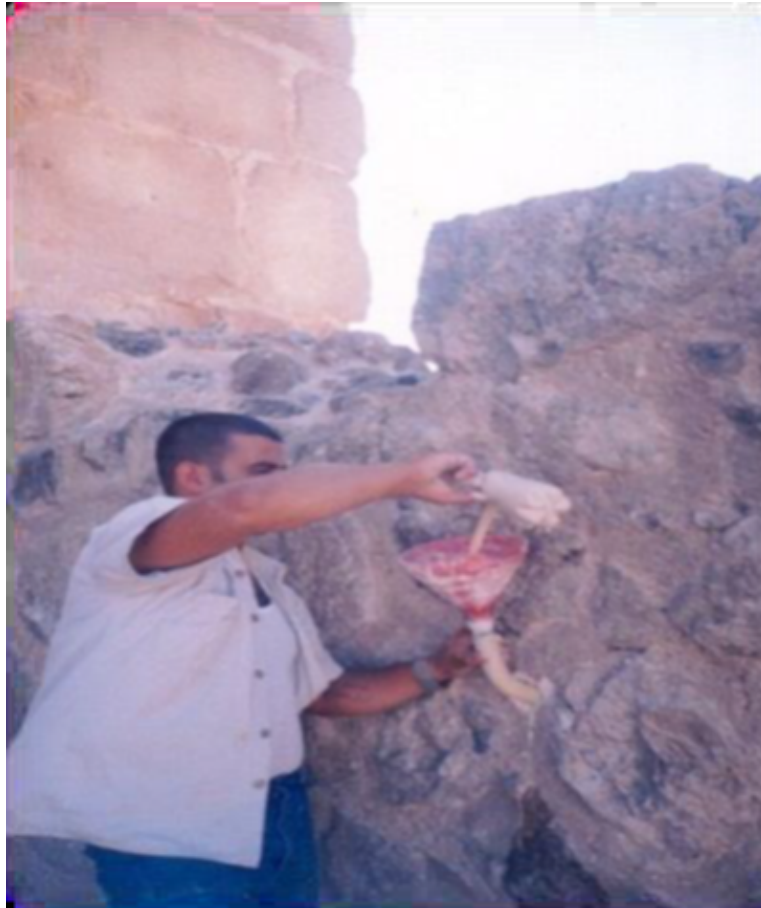
Figure: 12, injecting a new mortar into the spaces inside the wall  
(AKTC, 2007)

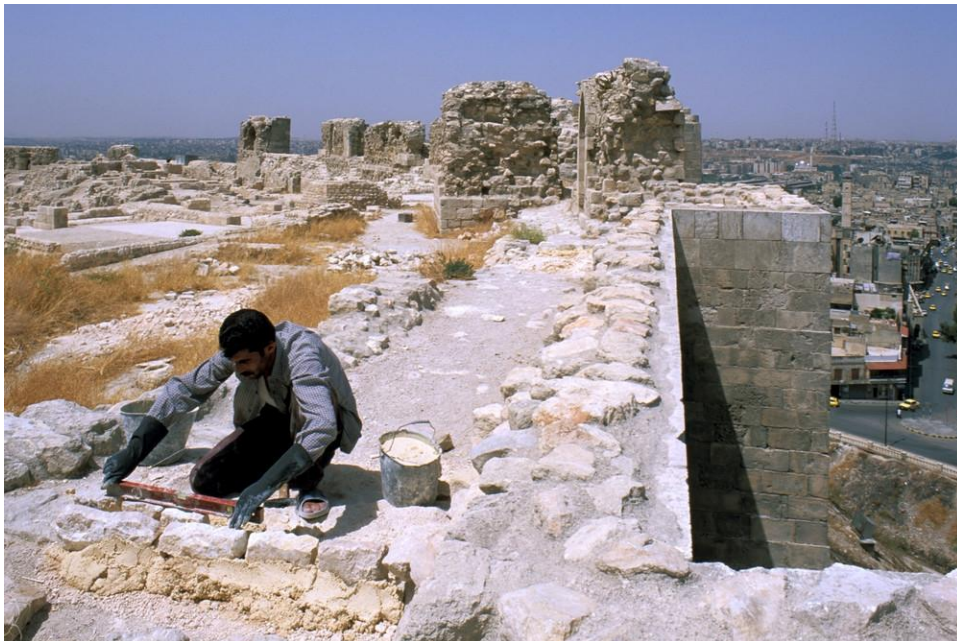
Figure: 13, injecting a new mortar into the spaces inside the wall  
(AKTC, 2007)

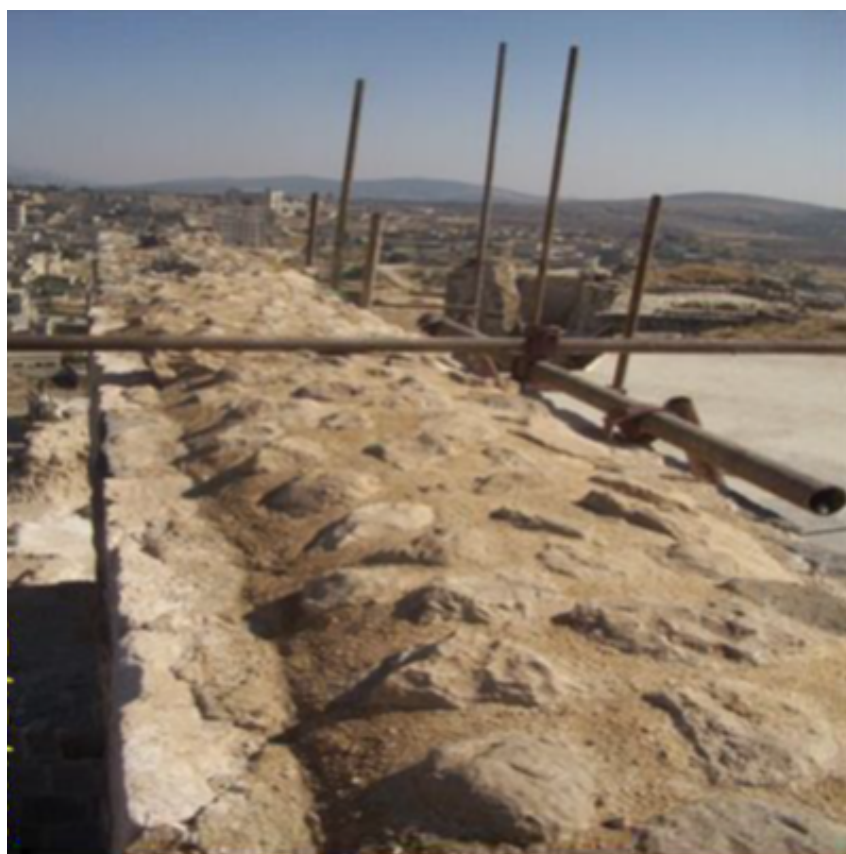
Figure: 14, the wall heads maintenance  
(AKTC, 2007)

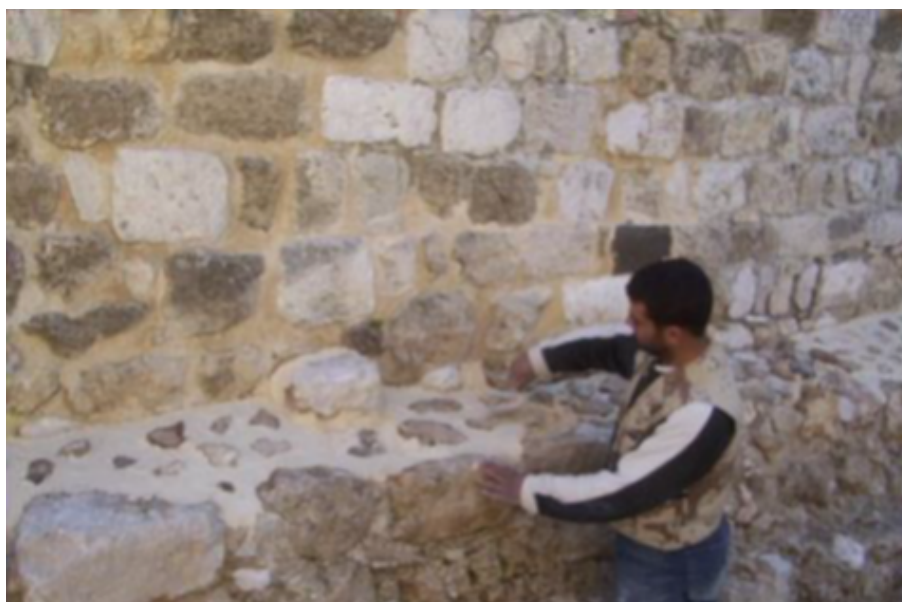
Figure: 15, the wall heads maintenance  
(AKTC, 2007)

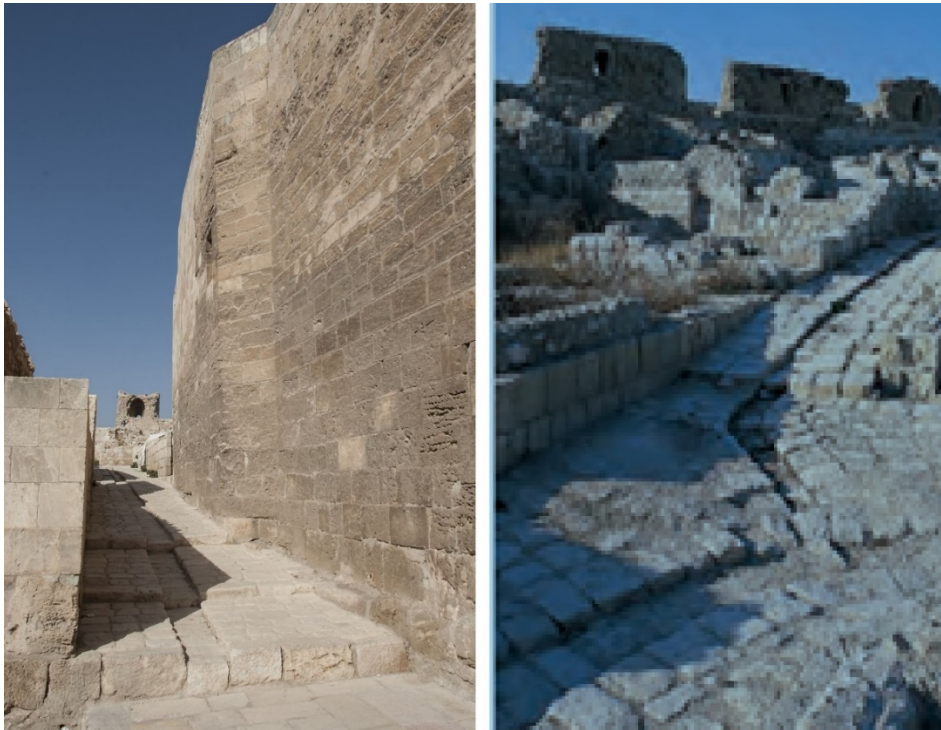
Figure: 17, improve the water drainage system within floors  
(Jodidio, 2011)
