7th International Conference on Building Resilience; Using scientific knowledge to inform policy and practice in disaster risk reduction, ICBR2017, 27 – 29 November 2017, Bangkok, Thailand

The changing city: risk and built heritage. The case of Lisbon downtown

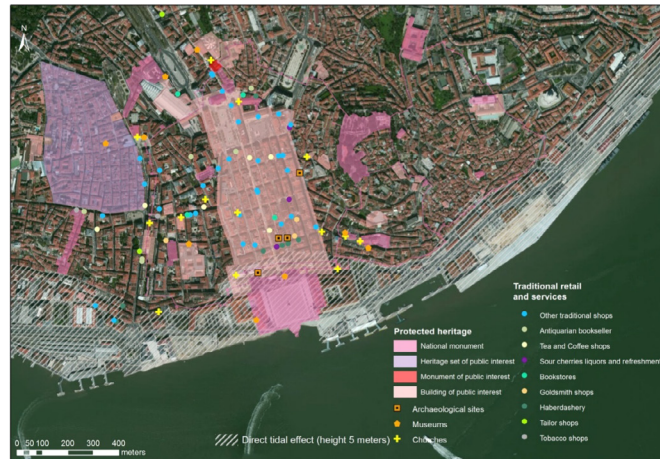
Figure 2 – Map showing exposure of the heritage of ‘Baixa Pombalina’ to seismic hazard (Source: Adapted from Lisbon Municipality, Municipal Master Plan of Lisbon, 2012, and based on field work).

The sectorial diagnosis of "Risks and Civil Protection" included in the Regional Plan of Lisbon Metropolitan Area (*Plano Regional de Ordenamento do Território da Área Metropolitana de Lisboa – PROT AML*) indicates that Lisbon Downtown is located in an area of very high seismic susceptibility (Mercalli intensity modified X to VIII) [6]. This is due not only to its proximity to active underwater structures bordering the Portuguese mainland, but also to a fault zone in the lower Tagus valley [22]. It is also built on soils of high seismic susceptibility (unconsolidated alluvium), both along the waterfront and over the ancient streams [14]. Figure 2 indicates the exposure of the built heritage of Baixa to seismic hazard.

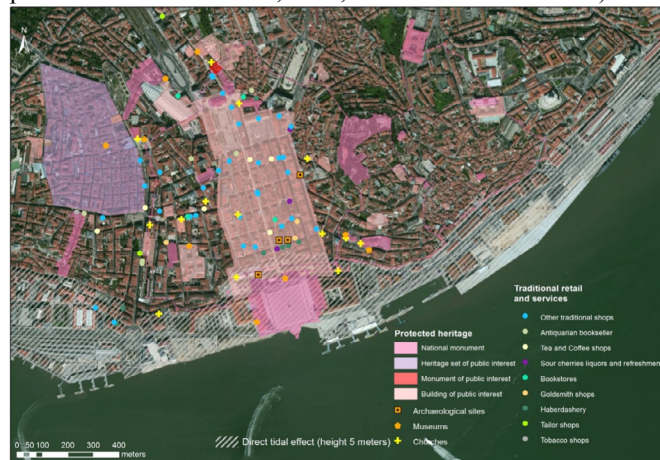
Figure 3 – Map showing exposure of the heritage of ‘Baixa Pombalina’ to direct tidal effect / 5m high tsunami (Source: Adapted from Lisbon Municipality, Municipal Master Plan of Lisbon, 2012, and based on field work).

Lisbon has been hit by strong tsunamis five times in the last 2000 years: two in the Roman period, two in the sixteenth century, and one following the great earthquake of 1755. The probability of a significant tsunami event has been assessed in seismic susceptibility studies, and is based primarily on historical records and the influence of the direct tidal effect. The risk assessment conducted for PROT-AML indicates that a tsunami could encompass the riverside area of Baixa to a height of 5 meters [22]. Refer to Figure 3.

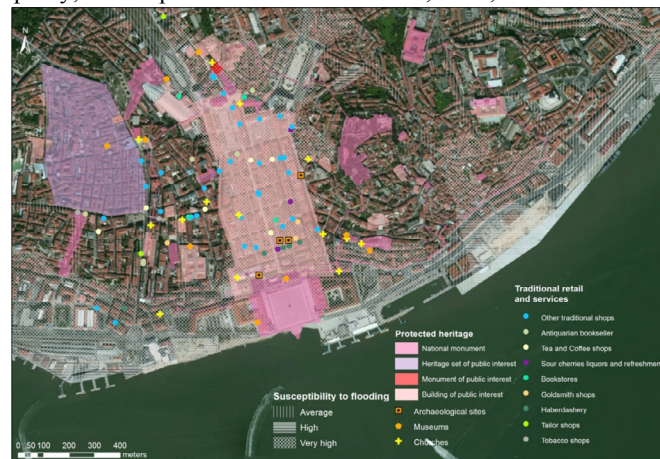
Figure 4 – Map showing exposure of the heritage of ‘Baixa Pombalina’ to flooding (Source: Adapted from Lisbon Municipality, Municipal Master Plan of Lisbon, 2012, and based on field work of the authors).

Historical records correlated with other variables such as slope, degree of ground permeability, ground water flow lines, direct tidal effect, and constraints of the urban sewerage and drainage network, show that the low-lying areas around Rossio and Praça do Comércio are the areas with the highest exposure to flood risk. However, other areas of Baixa are also shown as being at high to moderate flood risk, the exposure often coinciding with a concentration of drainage points, both natural and artificial. Figure 4 shows the exposure of Baixa’s heritage to flooding.
