Article

A Building Information Modeling Approach to Integrate Geomatic Data for the Documentation and Preservation of Cultural Heritage

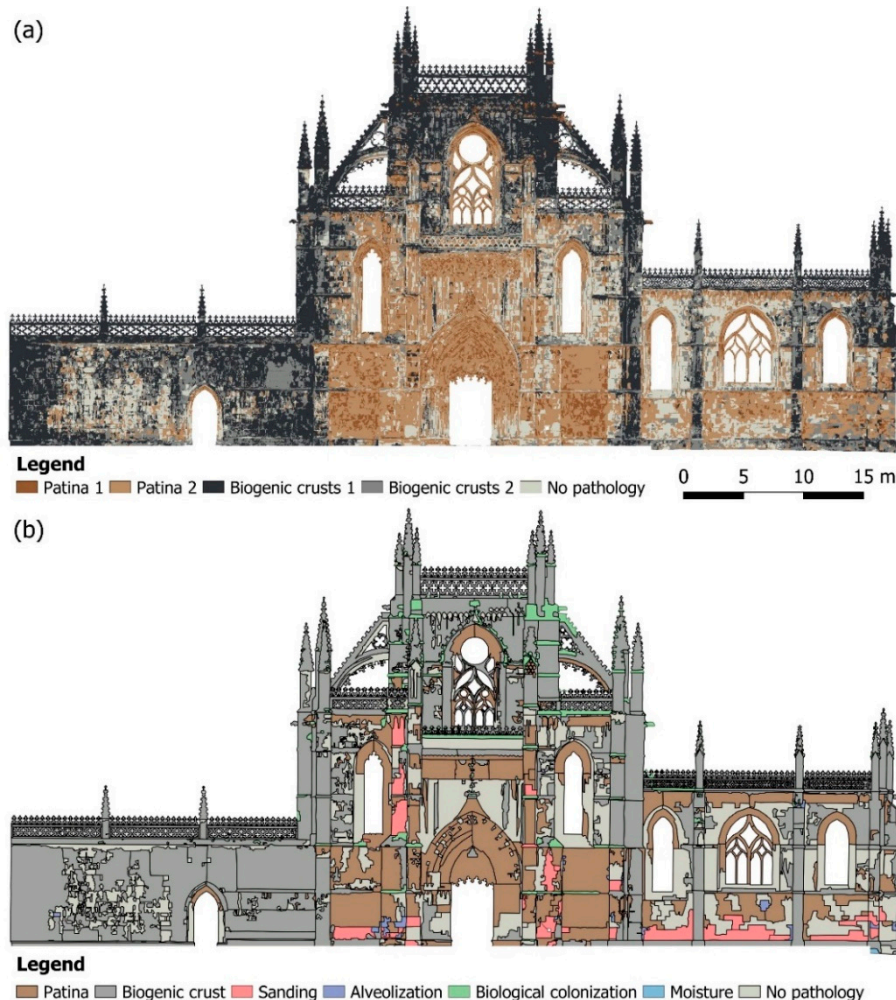
The main aim of the process was to compare the results obtained from the classic visual inspection with an automatic procedure, and the level of degradation in some cases was defined based on the difference of the colors. The method allows us to obtain a quantification of the area affected by a certain pathology and, if repeated over time, the evolution in terms of area affected. Due to the low spectral resolution of the camera and the reflected radiation properties of the stone, only two of the six types of anomaly of Figure 4 could be automatically identified: patina and biogenic crusts. Actually, different severity levels of patina and biogenic crust stains can be distinguished, so that each of them is subdivided in two subclasses: patina 1 and 2 and biogenic crusts 1 and 2. For instance, patina 1 is the severest or more advanced (having a darker tone) while patina 2 is still in an initial state (lighter tone)—biogenic crusts were similarly classified. By visual inspection of the orthophoto, a stratified random sample of 358 points was manually identified and used for training the supervised KNN classifier (with 5 nearest neighbors). Figure 7a shows the classification results of façade pathologies obtained by the KNN classifier. These automatically identified pathologies are in agreement with the pathologies identified manually by the visual inspection of the façade orthophoto (Figure 7b), which took 104 h for an experienced operator.

For assessing the accuracy of the OBIA classification, a stratified random sampling was used (Table 3). The overall accuracy of the automatic classification was high (76.5%) with a moderate agreement among the automatic classification and the reference data, given by a kappa coefficient

k = 0.71. The producer's accuracy (pa) was lowest for class patina 2 (59%) and highest for patina 1 (88%) and the no pathology class (87%). The user's accuracy (ua) showed higher values for biogenic crusts 1 and 2 (respectively 92% and 84%) and much lower values for patina 1 (59%).

Figure 7. Classification of anomalies on the main façade of MB: (**a**) automatic classification based on object-based image analysis (OBIA); (**b**) manual classification based on visual inspection.

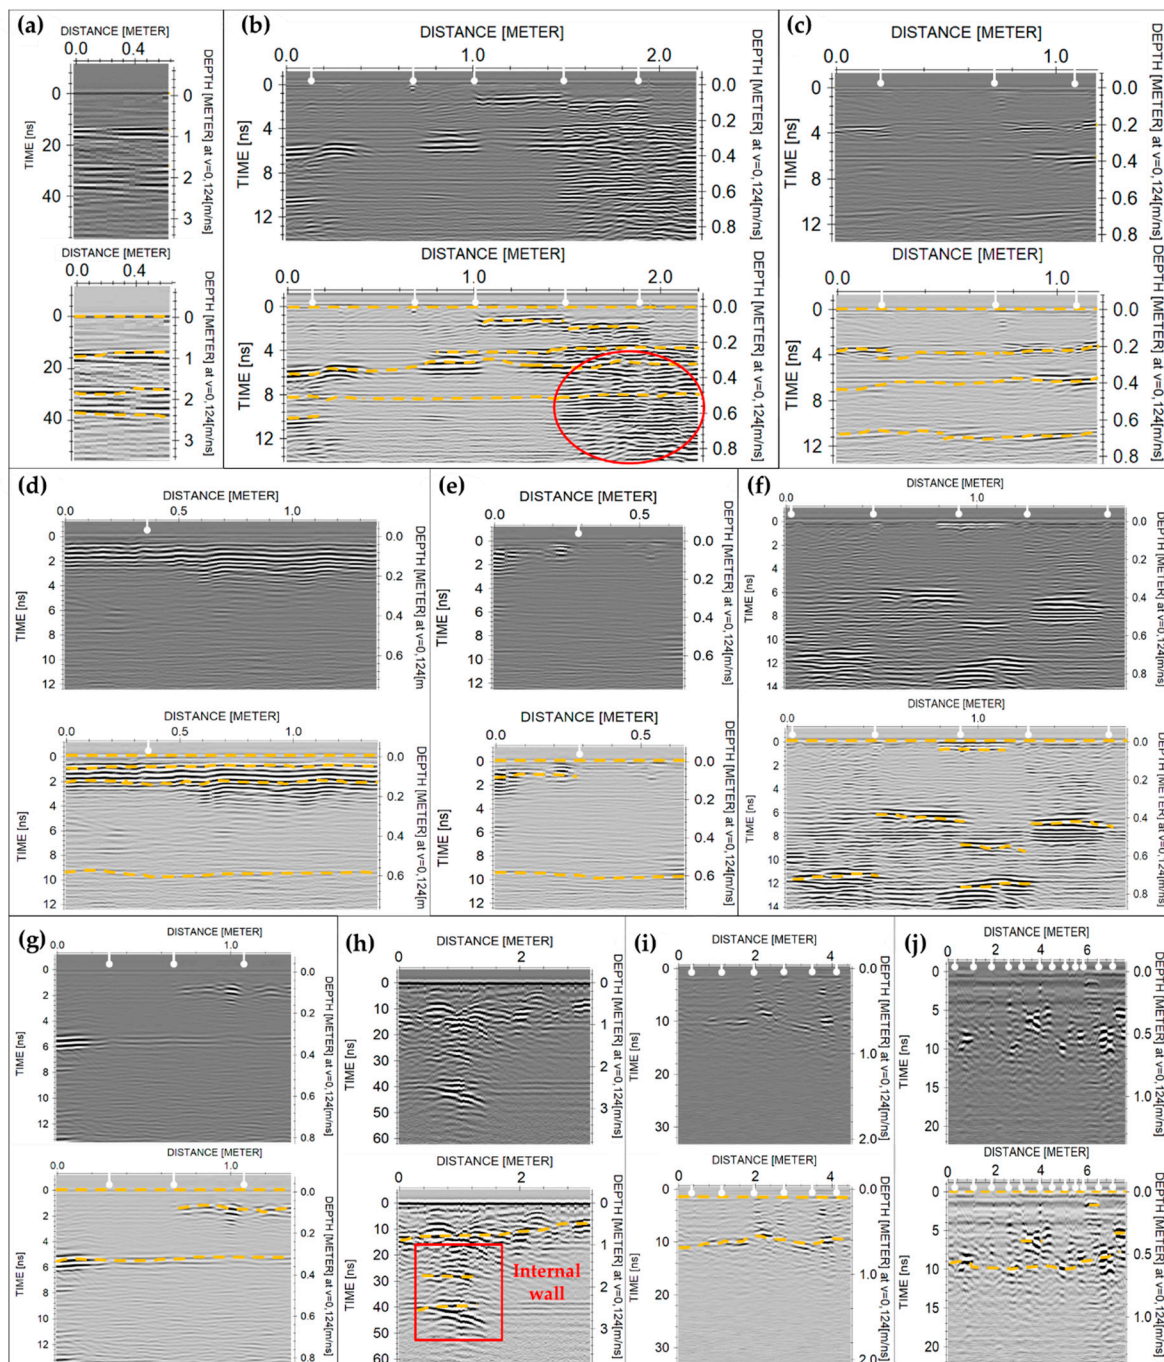
Figure 8 presents the radargrams obtained along the eight different zones (Z-1 to Z-8) of the main façade of MB (see Figure 2). First, Figure 8a presents the data produced with the 500 MHz antenna in Zone 1 (façade buttress). Three different depths of the inner surface of the ashlars are identified: the first at ~80–100 cm, the second at ~150–170 cm and the third at ~240–280 cm. Second, Figure 8b shows the 2300 MHz data obtained in Zone 2.1 (wall below lancet window of Founder's Chapel), while Figure 8c illustrates the 2300 MHz data produced in Zone 2.2 (buttress at the end of the arcade separating the nave from the right-hand aisle), showing the interpretation of the different stone's thicknesses. As seen in Figure 8b, a cavity (wall tomb) in the internal skin of the façade at Zone 2.1 causes (red ellipse) signal diffractions and complex pattern of reflections at the end of this profile (from 1.4 to 2.2 m), which were certainly produced by the cavity (gap) and the limestone arch above the internal wall tomb, respectively. Next, observing the 2300 MHz profile produced in Zone 3.1 (Figure 8d), it was realized that the bottom row of ashlars on the façade was recently restored using a stone ~10 cm thick; whereas observing the profile acquired in Zone 3.2 (Figure 8e), it was inferred that the second and third rows (from the bottom of the wall) are composed of the original stones ~50–60 cm thick. Figure 8f includes the radargram obtained with the 2300 MHz antenna in Zone 4, where both the original ashlars (thickness ranging from 40 to 70 cm) and those used in recent restoration interventions (thickness ranging from 2 to 12 cm) are detectable on the stonework of the façade. The thickness variation observed for a singular type of material is almost certainly caused by defects such as alveolization or by the unevenness of the inner face of the ashlars. Figure 8g presents the radargram obtained with the 2300 MHz antenna in Zone 5. As in Zone 4, it was possible to observe the presence of both original (~35 cm thick) and new (~8–10 cm thick) ashlars, the latter used for restoration. Regarding Zone 6, Figure 8h illustrates the radargram produced with the 500 MHz, showing three different layers of ashlar at ~60, 130 and 200 cm in depth. The reflection observed at 200 cm depth at the beginning of the radargram is most certainly produced by the wall separating the Royal Cloister from the Church, which is perpendicular to the surveyed façade. Figure 8i presents the radargram obtained with the 800 MHz frequency antenna in Zone 7. Observing these radargrams, a single layer of ashlars ~60 cm thick is identified. Finally, Figure 8j displays the radargram obtained with the 800 MHz frequency antenna in Zone 8, where both original (thickness ranging from 50 to 60 cm) and recent ashlars (thickness ranging from 5 to 10 cm) are distinguishable on the stonework of the façade.

Figure 8. GPR data produced on the main façade of MB: (**a**) 500 MHz data in Zone 1, (**b**) 2300 MHz data in Zone 2.1, (**c**) 2300 MHz data in Zone 2.2, (**d**) 2300 MHz data in Zone 3.1, (**e**) 2300 MHz data in Zone 3.2, (**f**) 2300 MHz data in Zone 4, (**g**) 2300 MHz data in Zone 5, (**h**) 500 MHz data in Zone 6, (**i**) 800 MHz data in Zone 7, (**j**) 800 MHz data in Zone 8. (Vertical white marks are the field marks used for data integration, which corresponds to the separation of successive external stone blocks, while horizontal yellow dashed lines indicate the separation of successive internal stone blocks.).

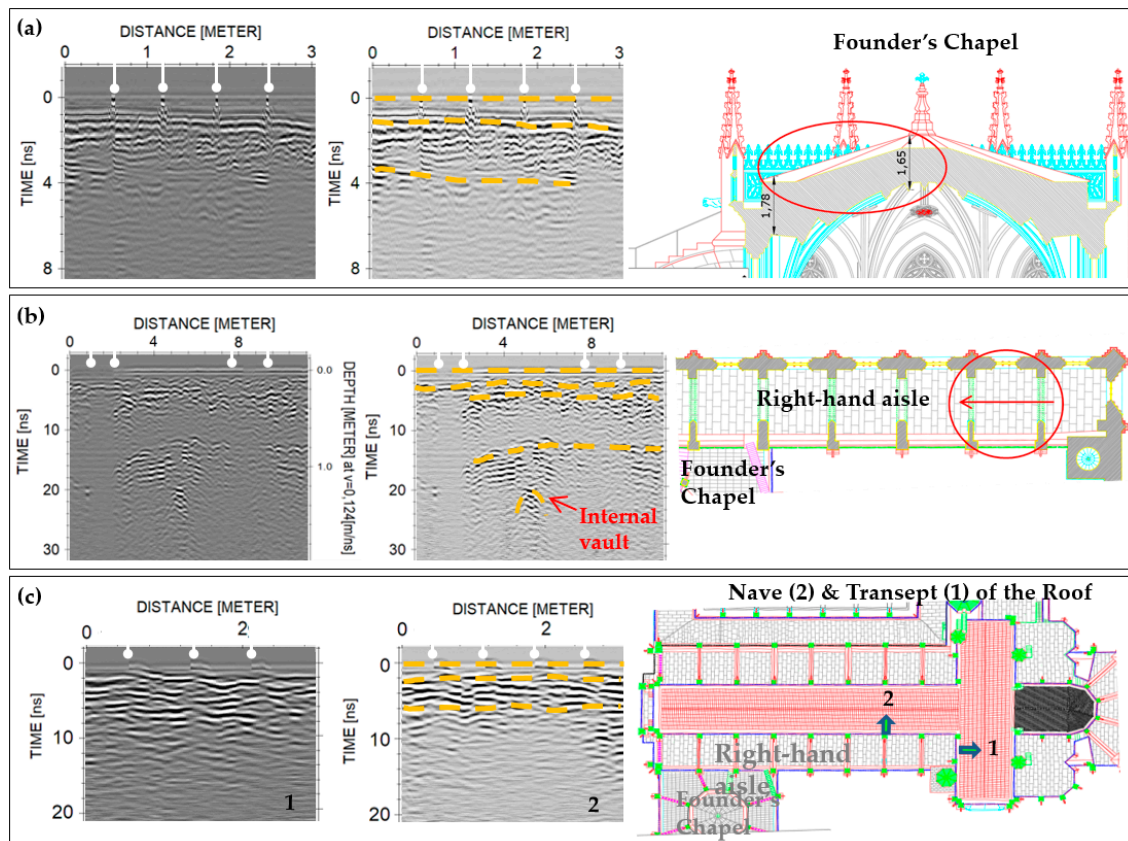
Figure 9 includes the GPR data acquired on the roof of both the Church and the Founder's Chapel (see Figure 2). First, Figure 9a presents the radargram obtained with the 2300 MHz frequency antenna through the roof of the Founder's Chapel (Figure 8b), showing the interpretation of the superficial limestone tiles and stronger reflections at the internal fill layers. Regarding this effect, previous maintenance works carried out on the roof of the Founder's Chapel, in which some cladding tiles were

removed, revealed a fill layer made of lime mortar, stones and ceramic tiles. The scattering observed is certainly produced by the presence of such heterogeneous filling. Next, Figure 9b shows the radargram obtained with the 800 MHz frequency antenna on the roof above the right-hand aisle (second bay counting from the transept). It allowed for measuring the thickness of the cladding plates and of the internal fill layer (~20 cm and 80 cm thick, respectively), and to identify the top of the underneath ribbed vault (possibly its keystone). Finally, Figure 9c illustrates the radargrams obtained with the 800 MHz frequency antenna on the roof of the Church, above the nave and transept (see Figure 2), showing the cladding tiles and the internal fill layer.

Figure 9. GPR data acquired on the roof of the Church and of the Founder's Chapel: (**a**) 2300 MHz data on the roof of the Founder's Chapel, (**b**) 800 MHz data on the roof above the right-hand aisle, and (**c**) 800 MHz data on the roof of the Church (above the nave and transept). (Vertical white marks are the field marks used for data integration, which correspond to the separation of successive external tiles, while horizontal yellow dashed lines indicate the separation of successive internal layers.).

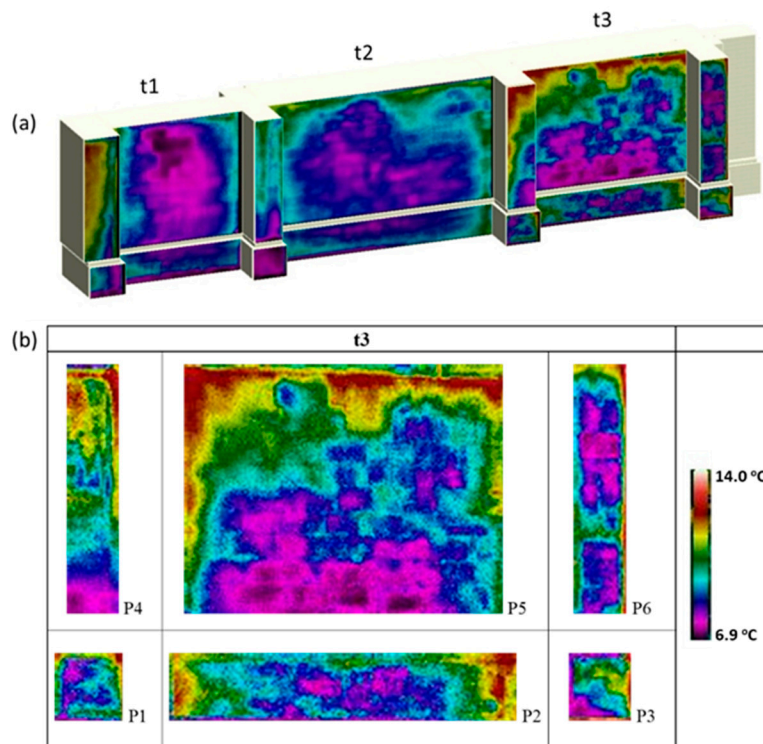
Figure 10 shows the images captured with the thermographic camera on the study area, and identifies the three wall spans t1, t2 and t3, bordered by the buttresses. Figure 10b shows the images captured on the wall span t3 (images P5 and P2) and bordering buttresses (images P1, P3, P4 and P6). In the areas closest to the ground (P1, P2 and P3) lower temperatures are observed (tones purple to blue in the thermogram), which are probably due to the presence of moisture, both absorbed from the ground (rising damp) and infiltrated in the façade, as confirmed by visual observation. The different colors are associated not only with different humidity levels but also with the material and pathology types–as they imply different absorption of solar radiation and, therefore, different energy emissions captured by the thermogram–and with the thickness of the limestone blocks. There seems to exist some match for areas with patina and also in the presence of stones resulting from recent restoration works in the upper middle part of P5 (Figure 10). In addition, higher temperatures (reddish

color) are observed (1) near the pier buttresses, on the left-hand side of P5, which appear to be caused by the presence of the buttress, and (2) on the frieze at the top of P5, close to the window sill.

Figure 10. Infrared thermography of the study area: (**a**) areas t1, t2 and t3 of the Founder's Chapel; (**b**) thermographic images for area t3.

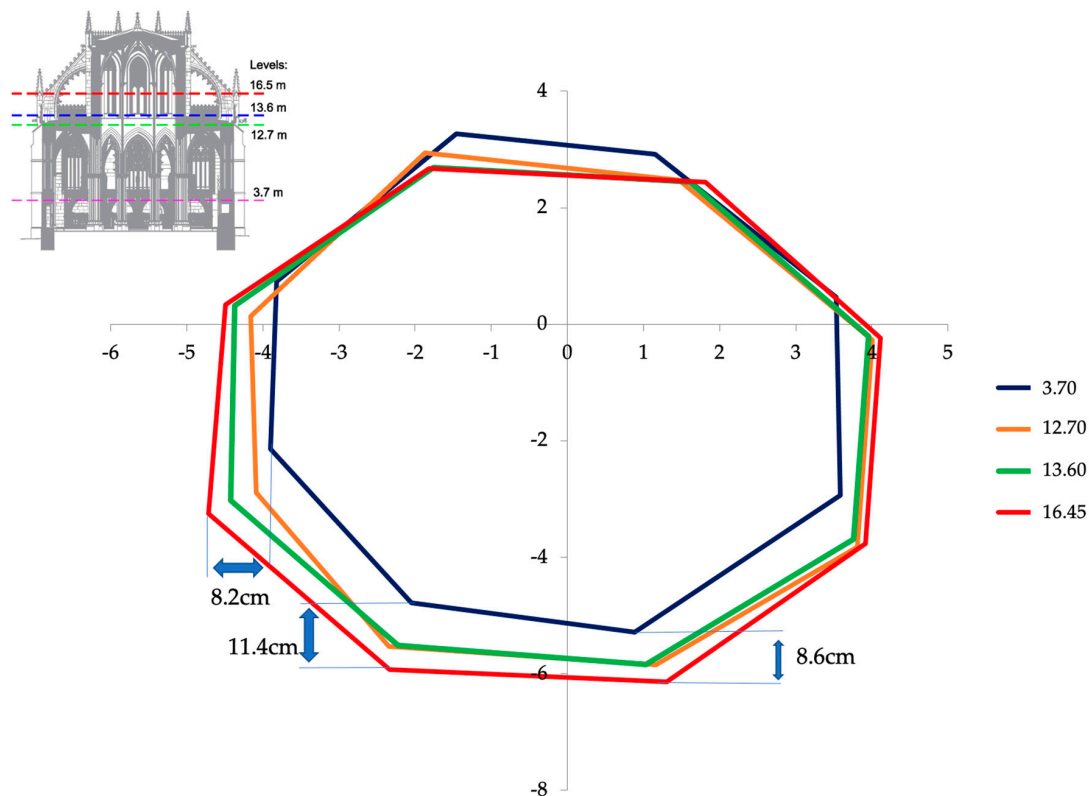
The interior of the chapel was analyzed according to 8 vertical alignments corresponding to the 8 central columns of the Founder's Chapel, located between the windows of the octagon at the roof level. The coordinates of four points were taken in each vertical alignment at 3.7 m, 12.7 m, 13.6 m and 16.5 m from the floor (see Figure 12). In this figure, the lower level (3.7 m) dimensions are in natural scale and the others have a factor scale increase of 20 with respect to the coordinate difference to that lower level. The figure shows that the Founder's Chapel presents at its higher level a displacement to the south (maximum of 11.4 cm), east and west (maximum of 8.2 cm) sides, possibly due to misalignment during the construction stage or in consequence of seismic activity (the original roof collapsed during the Lisbon earthquake of 1755 [69]). The figure also shows that the part of the octagon on the side of the Church suffered smaller displacements possibly because of the structure's higher stiffness in that direction (it may even have been pushed away from the Church by its horizontal impulse). The results show an average column inclination of about 8 mm/m. These displacements are probably the main reason for the open joints above the windows. It is possible that either the roof collapse due to the earthquake of 1755 or the construction of the new roof may have worsened the octagon deformation. By comparing the results of future surveys with those now obtained, it will be possible to determine if this motion is still evolving or if it has already stabilized.

Figure 12. Horizontal displacement at four different levels (3.7 m to 16.45 m) of the star vaulted octagon of the Founder's Chapel.

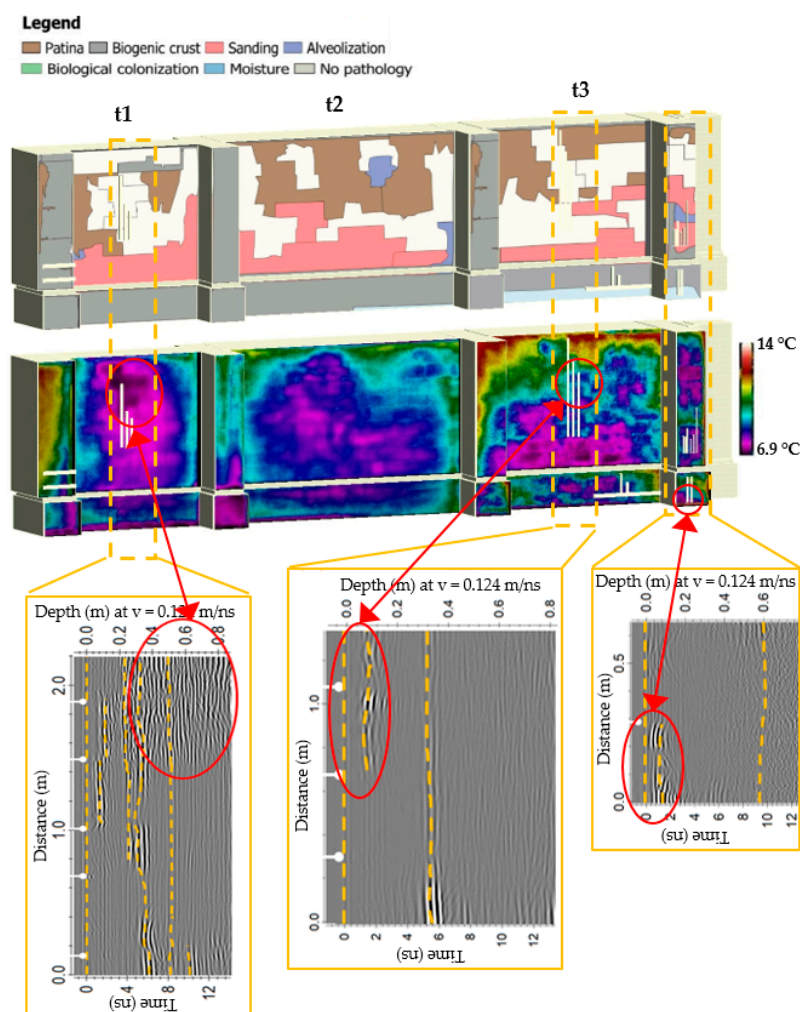
Figure 18, respecting the Founder's Chapel façade, illustrates a possible analysis of the combined representation of the OBIA classification, IRT and GPR imaging, showing the potential of the integration of data captured with different sensors (different ranges of penetration) into a BIM model (spatially overlapped). The areas highlighted with red circles can be interpreted as "anomalies" (different distribution of temperature, different time of reflection, etc., when compared with the surroundings). By analyzing the different information for the areas P5 and P6 of section t3 (see Figure 10), it may be concluded that zones with stones introduced during recent restoration works might show a lower temperature (IRT) and lower thickness of the blocks (GPR) and a "no pathology" status in the automatic classification. Also, regarding the central wall in section t1, the area having the lowest temperature (highlighted with a red circle) matches spatially the cavity detected with the GPR. Thus, the wall is less thick at this point, which corroborates that smaller thicknesses were associated with lower temperatures.

Figure 18. Analysis of the combined representation of the OBIA classification (UAS imaging), IRT and GPR results: the areas highlighted with red circles can be interpreted as "anomalies".
