Cut slopes failures on the Triassic beds in Coimbra, Portugal

Abstract Several cut slope failures that occurred in the Triassic “Grés de Silves”, in the area of Areeiro in Coimbra, Portugal, are analysed. They developed along thin mudstone layers dipping at some 16° towards the face of the excavation. The failures mainly occurred after periods of intense rainfall, in some cases immediately after the excavation of the slope and in some cases have continued for the seven years since, even where the slope height was only a few metres. The conditions leading to the failures were investigated in the field and in the laboratory. It was concluded that the main factors inducing the slope failure are a conjugation of the geological structure and the reduction in the shear strength of the mudstones when the excavation results in dilation, such that fissures open allowing the ingress of water.

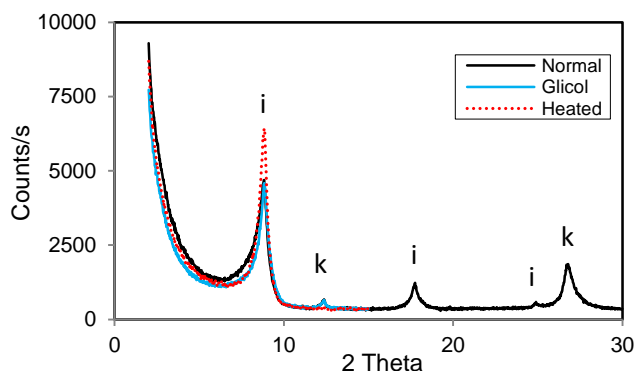
The mineralogy of the mudstone was studied using X-ray diffraction. The samples were manually disaggregated and a suspension was prepared in order to separate the coarse fraction from the clay fraction, based on Stokes Law. The X-ray diffraction of the coarse material revealed the presence of quartz, potassium feldspar, mica and traces of dolomite, while the clay fraction contained predominantly illite, kaolinite, and an interstratified illite-vermiculite (Fig. 9).

Fig 9 X-ray diffractograms of the clay-fraction of sample A11-1 collected in the slope of Areeiro School. k - kaolinite; i – illite

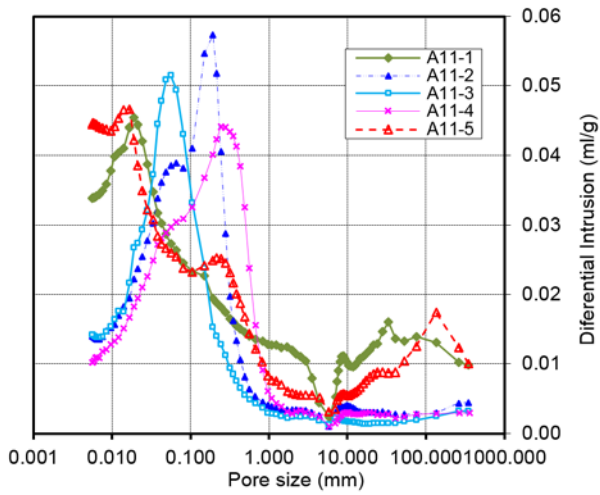
For the five mudstone samples, the average of the pore diameter ranges from 0.03 to 0.05 μm , (Table 2), while the mean is between 0.01 and 0.28 μm , (Fig. 10), corresponding to materials with a narrow range of low pore sizes. The porosity of the five samples varies between 12% and 19% (Table 2).

Fig. 10 Relation between the pore diameter and the differential intrusion of mercury

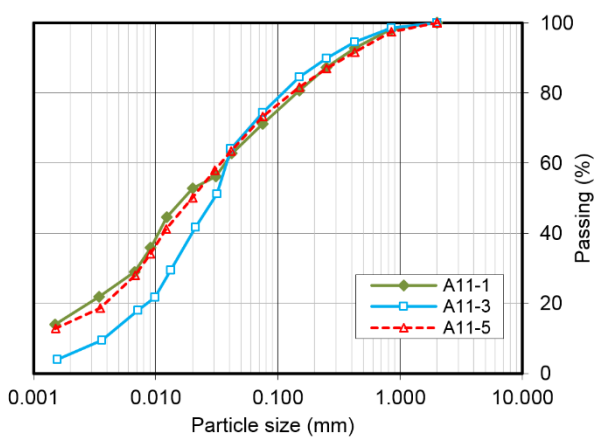
Samples A11.1, A11.3 and A11.5 were characterised through wet sieving, sedimentation and consistency tests. All the collected samples were dried and crushed to powder. They were then prepared at water content close to the plastic limit and allowed to equilibrate for 24 hours. Particle size distribution curves are represented on Fig. 11, and in Table 3. The soil classification test results are shown in Table 3.

The clay activity of samples A11.1 and A11.5 suggests the presence of illite, confirming the X-ray identification. For sample A11.3 the low clay content precludes any reliable interpretation.

Fig. 11 Particle size distribution curves of samples

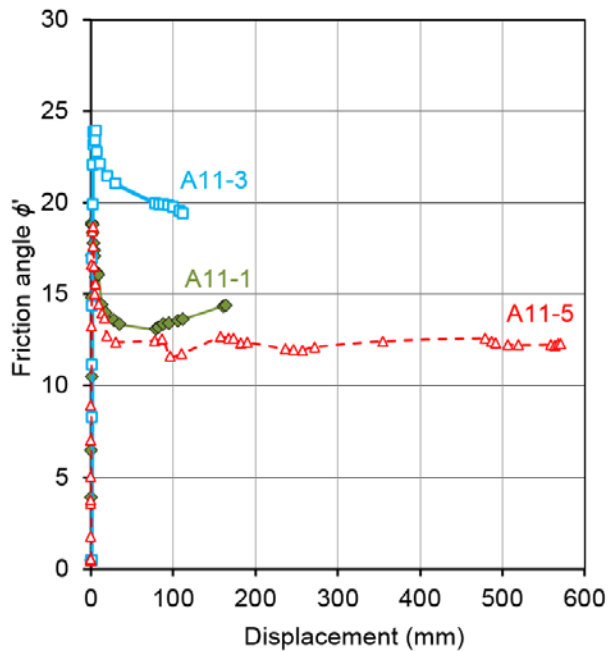
After residual conditions were reached (stage 2), each sample was over-consolidated to 400 kPa and the load reduced to 200 kPa which would allow some expansion. It was then re-sheared at 200 kPa (stage 3) and the shear mode investigated as proposed by Lupini (1981). The results showed a brittle behaviour in the first shear (Fig. 13) but no “peak” was observed in stage 3, indicating a sliding shear mode. The first shear of a normally consolidated structure shows a brittle failure. ABF, due to the clay alignment in the shear surface. Re-shearing an overconsolidated shear surface with the clay particles perfectly aligned will not show the brittle behaviour, CG. The decrease in void ratio due to overconsolidation did not create a peak as would be observed in a dense sand (CDE). Figure 13 shows the normally consolidated (fully softened) shear strength and the residual shear strength expressed in terms of the friction angle, assuming no cohesion; the values are given in Table 6.

Fig. 13 First shear stages at a normal stress of 400 kPa

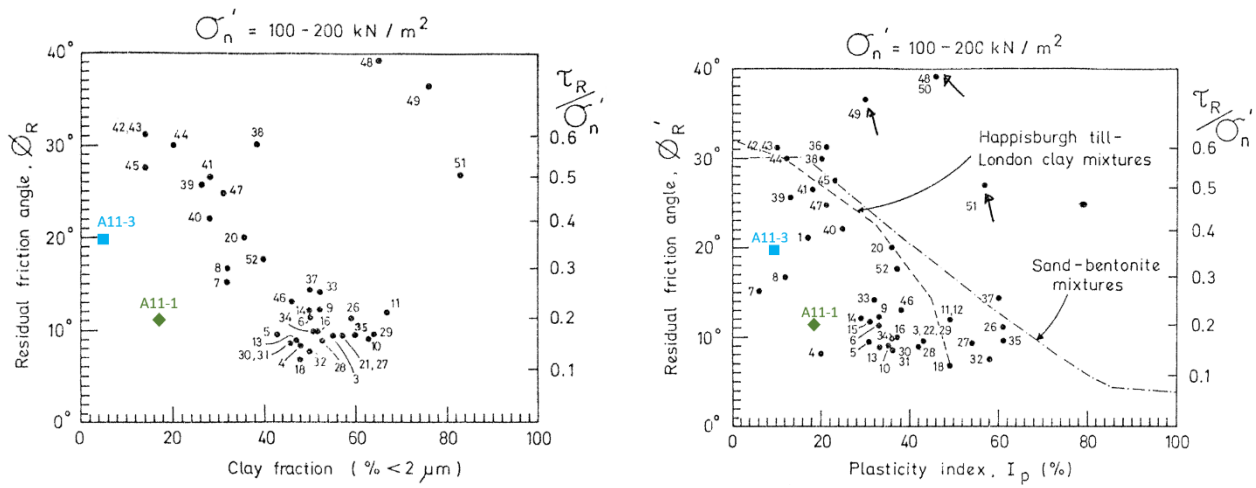
Following Lupini (1981), the samples A11-1 and A11-5 show a sliding mode of shear with the clay particles perfectly aligned and parallel to the shear direction. Figure 14 compares the residual shear strength obtained for the mudstones and other soils reported by Lupini et al. (1981). It can be seen that the residual shear strength of the mudstone is considerably lower than the corresponding value of other soils with the same clay fraction and plasticity.

Fig. 14 Residual shear strength of the mudstones compared with other soils reported by Lupini et al. (1981)

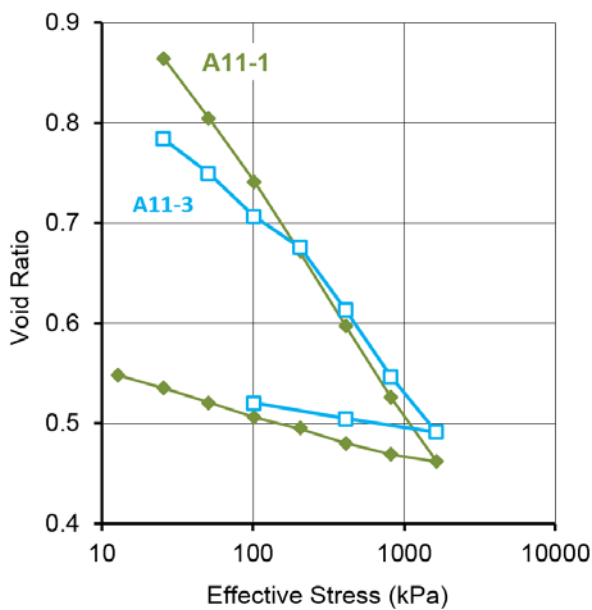
for samples A11-1 and A11-3. Figure 15 presents the variation of the void ratio for two samples with effective stress using a logarithmic scale. The compression index (C_c) and the swelling index (C_s) have been calculated in Table 9. Comparing the values of the void ratio obtained in the oedometer test with the values of porosity obtained from the mercury porosimeter (18.5%), Fig. 14 and Table 9 indicate that the soils have experienced normal effective stresses as high as 15 MPa in the past.

Fig. 15 Variation of the void ratio with the effective stress for two samples, A11-1 and A11-3
