Review

UAV-Based Structural Damage Mapping: A Review

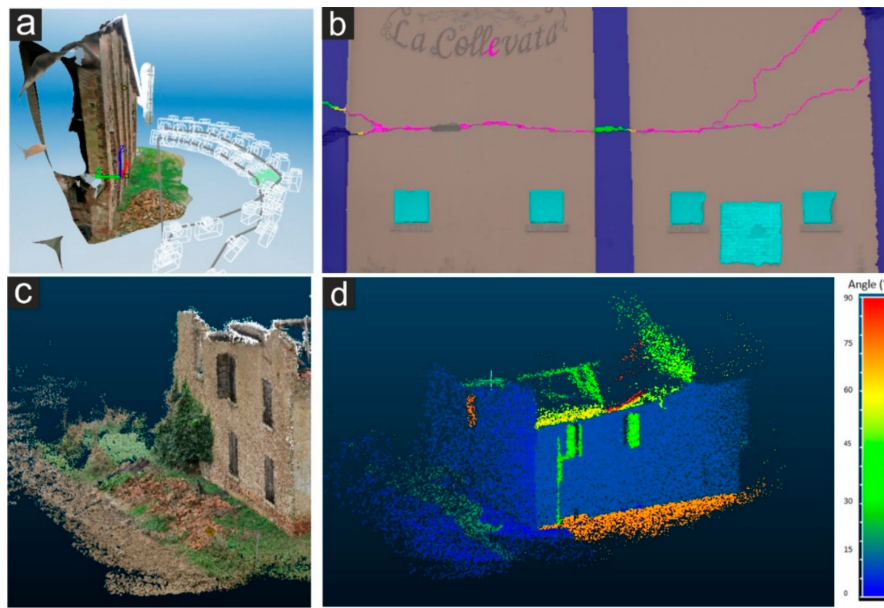
Figure 1. Damages identified from unmanned aerial vehicle (UAV)-derived point clouds and from object-based image analysis (OBIA) processing. (a) Inclination in walls, (b) openings (turquoise), cracks (magenta), and damage crossing beams, (c,d) detailed point cloud and segment orientation angles [adapted from 36].

Initial attempts to extract damage information automatically from UAV data were based on segmentation- and texture-based approaches, using mono-temporal imagery. Fernandez Galarreta et al. [36] processed UAV imagery of an 2012 Emilia Romagna (Italy) earthquake site into detailed 3D models. The work adapted and expanded earlier approaches developed for the airborne (piloted) Pictometry system that yields similar oblique, overlapping, and multi-perspective imagery. Also, those images had been photogrammetrically processed [37], and used for structural damage assessment [38,39]. The analysis of [36] focused on geometric damage indicators such as slanted walls or deformed roofs, as well as presence of debris piles (Figure 1). In addition, object-based image analysis (OBIA) was carried out on the images to extract damage features such as cracks or holes, but also identification of those damage features intersecting with apparent load-carrying structural elements. A similar OBIA strategy was used by [40] to identify damage in Mianzhu city, affected by the 2008 Wenchuan earthquake.

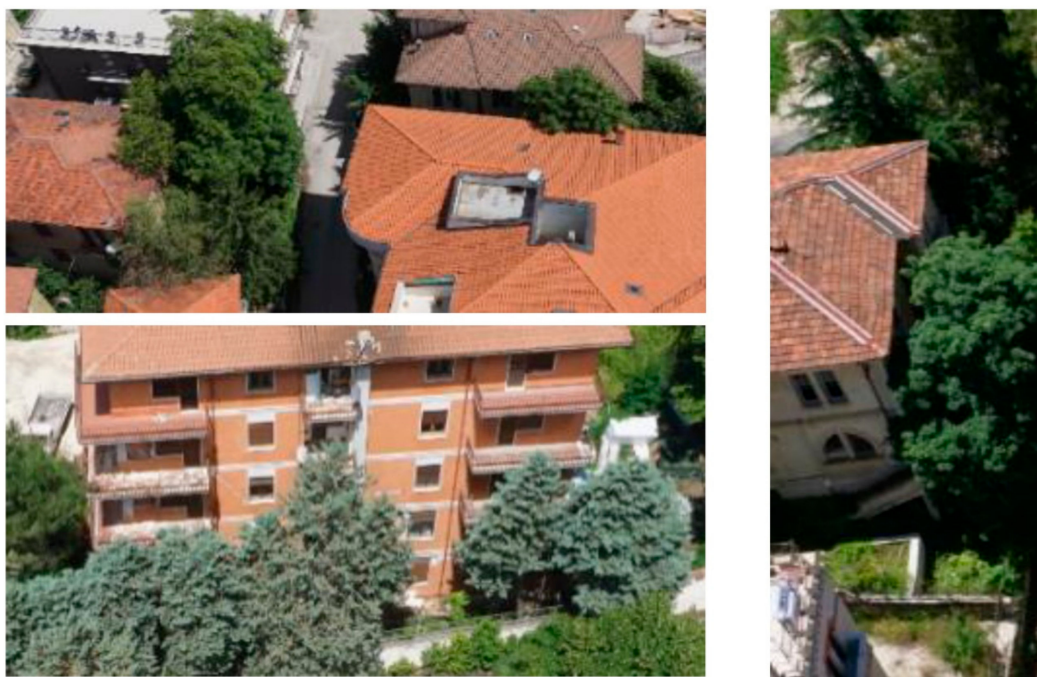
Figure 2. Typical problems for image processing posed by shadow and occlusion [51].

Earlier work had shown how highly variable the expression of structural damage is in vertical and oblique data [6]. The former essentially only considers the damage expressed in the roof, and in addition makes use of proxies such as debris piles for specific shadow configurations [7]. Significant additional information is also encoded in the façade information, as already explained in Section 2.1. However, the OBIA-based approach used for example in [36] tends towards overfitting and lacks the efficiency and transferability of deep learning. While a focus on façades is appealing, their actual delineation in imagery poses its own challenges, especially when considering aspects such as occlusion or environmental effects such as shadows (Figure 2). The work described in [51] thus focused on developing an efficient method to extract façades that were subsequently assessed for damage using CNN. The approach made use of a point cloud calculated from vertical imagery acquired in an initial UAV survey. From the sparse point cloud, the building roofs were segmented and the building façades hypothesized, which in turn was used to extract the actual façades from oblique UAV images. The patch-based damage classification had an overall accuracy of approximately 80%, though the work also demonstrated the significant challenge of damage identification on façades, due to architectural complexities and associated diverse shadow patterns, but also occlusion (by external features such as vegetation, or internal ones such as balconies).

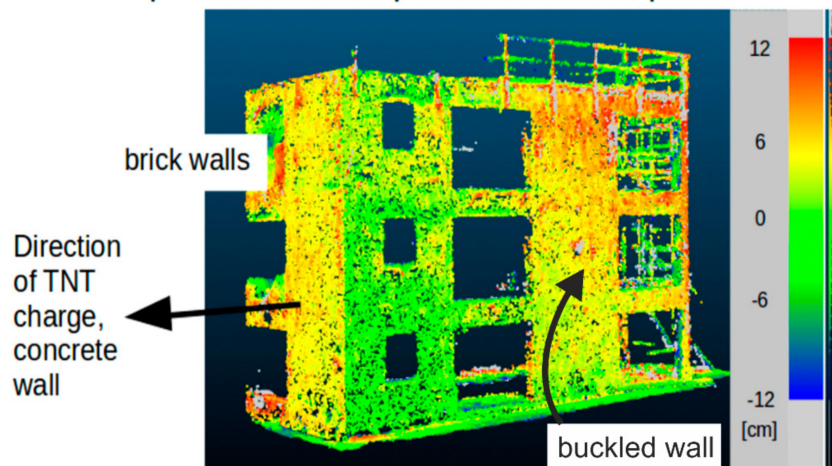
Figure 3. UAV-derived point clouds of reinforced concrete structure with brick in-fill walls subjected to exterior and interior detonations. Openings, cracks, and debris piles, as well as subtle deformation in the façades were automatically detected.

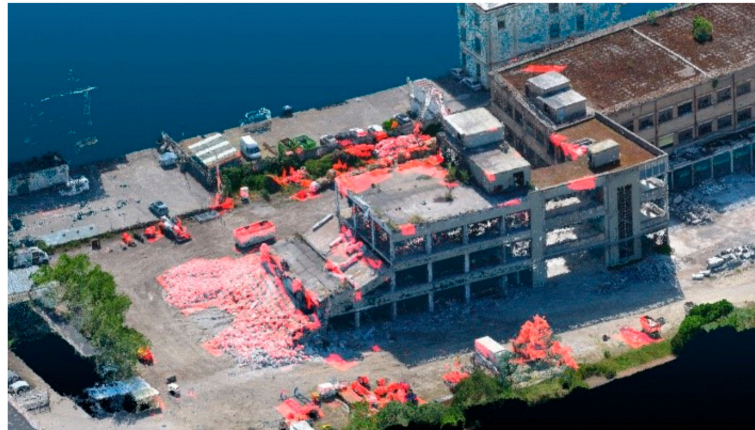
Figure 4. Point cloud representation of an INACHUS pilot structure in Lyon, France, calculated from optical imagery acquired with a low-cost commercial drone (Phantom 4, DJI), showing damage detected through machine learning (red).

Figure 7. Voids within the photogrammetric model shown in Figure 4, obtained with a terrestrial laser scanning system. (a) Estimated size of open spaces observed through openings, (b) distance of voids to the edge of the building.

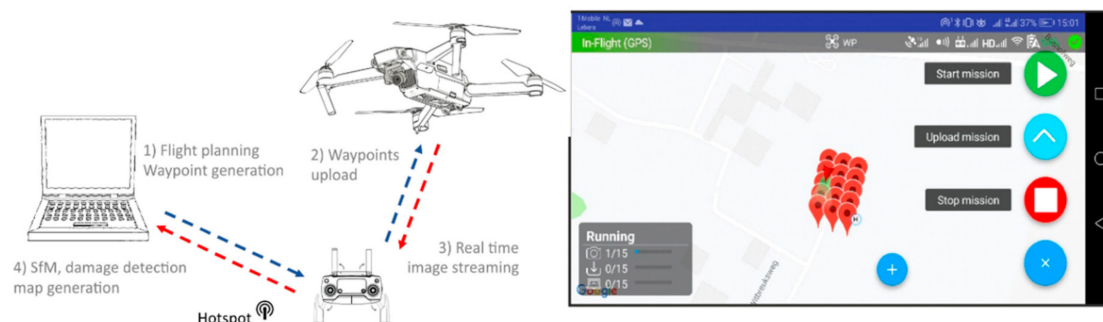
Figure 5. Workflow of the app developed for near real-time damage mapping. Images are streamed to a laptop computer and processed immediately after acquisition. A convolutional neural network (CNN)-based damage detection algorithm is applied, and a progressively built sparse 3D model is used to orthorectify them. By the time the UAV lands, an orthomosaic displaying the damage is finished (adapted from [59]).

While commercial UAVs by DJI and other makers have clearly reached high levels of cost-benefit, stability, and reliability, most are also not designed to be survey-grade instruments working in real time. For rapid search and rescue support it is vital to provide usable information quickly. For that reason, in INACHUS a procedure was developed to process the data with minimal delay. Working with the ability of the Mavic Pro to stream images during flight, a procedure was built that (i) downloads images right after acquisition, (ii) builds a progressively extended sparse 3D model of the scene using established SfM methods, (iii) applies CNN to detect damage, and (iv) orthorectifies the images using

the 3D model. By the time the UAV lands after a maximum flight duration of about 25 min, all processing is done and the damage map available. A smart phone app was also built that allows this procedure to be executed together with a standard laptop (Figure 5). Details about the app and data processing workflow can be found in [59], while more information about the optimized CNN that was made available on GitHub can be found in.

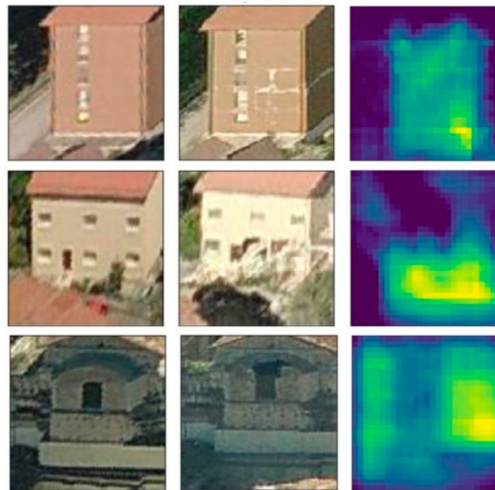
Figure 6. Examples of building damage detection via CNN activation layers, using aerial pre- and post-earthquake façade images. Bright activation colors show damage hotspots (adapted from [61]).

Work such as in [56,57] tends to focus on activation layers that indicate the presence and approximate position of damage (Figure 6), rather than the creation of actual damage maps. From a user perspective, more clarity on the specific damage type, but also more precise location, shape, and size, would be preferable. In addition, the nature of CNN-based studies prevents insights into how specifically a network with superior overall accuracy performs in terms of reducing false positives or negatives.
